No reverse, rear band strut breakage

Reverse Band Strut

32710-01

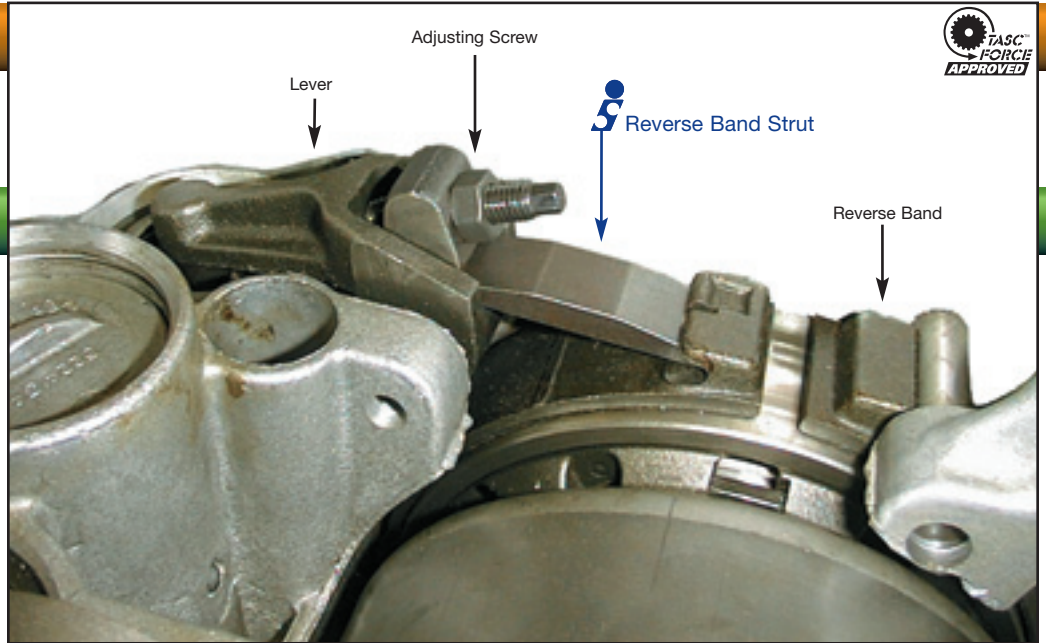
1 Reverse Band Strut

Thin struts cannot withstand the force of the servo piston rod as it applies the reverse band.

This Sonnax reverse band strut has a thicker cross section and is made of higher yield strength alloy steel.
