TF-80/81SC

PART NUMBERS 39741-22K, F-39741-TL22

B1 Band Control Valve Kit

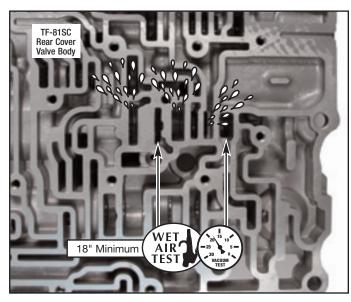
Wear at the B1 band control valve bore affects apply and release rate of the servo.

Either a Wet Air Test or a Vacuum Test in the locations shown, result in leakage. A vacuum test must hold a minimum of 18".

The replacement Sonnax sleeve and valve corrects circuit pressure loss and restores control of band apply and release.
