2-3 upshift flare

Sonnax Part Summary

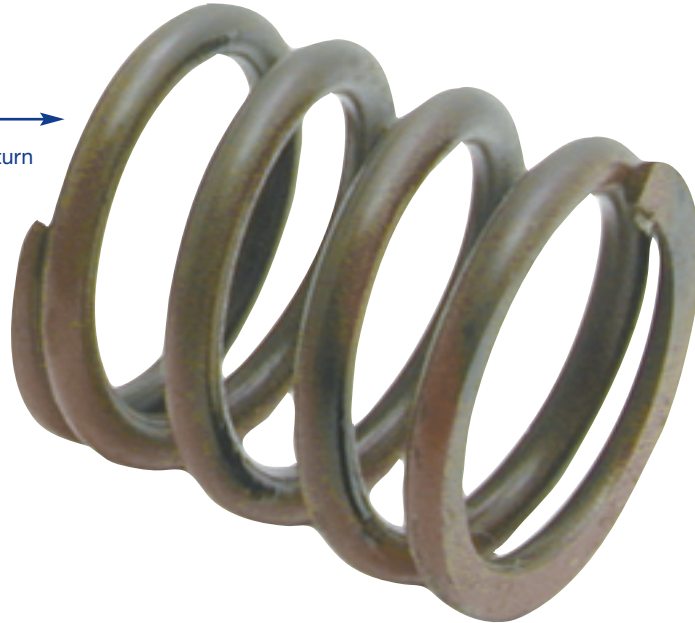
Servo Return Spring

- Soft 1-2 or 3-4 upshift

The servo timing and apply rate of the direct clutch become poor due to low pressure, servo leakage and/or pin bore wear.

Installation of the spring will slow the release of the band on a 2-3, yet allow quicker servo travel on reapplication. This results in shorter shifts throughout.

- Replacement spring provides enough force to firmly apply the 2-4 band, yet is not overly stiff so that a controlled release is allowed.
- Spring will work with both the one-piece or two-piece servo piston and rod assembly.
