Throttle Valve Plug & Sleeve

76989K

Sonnax Part Summary

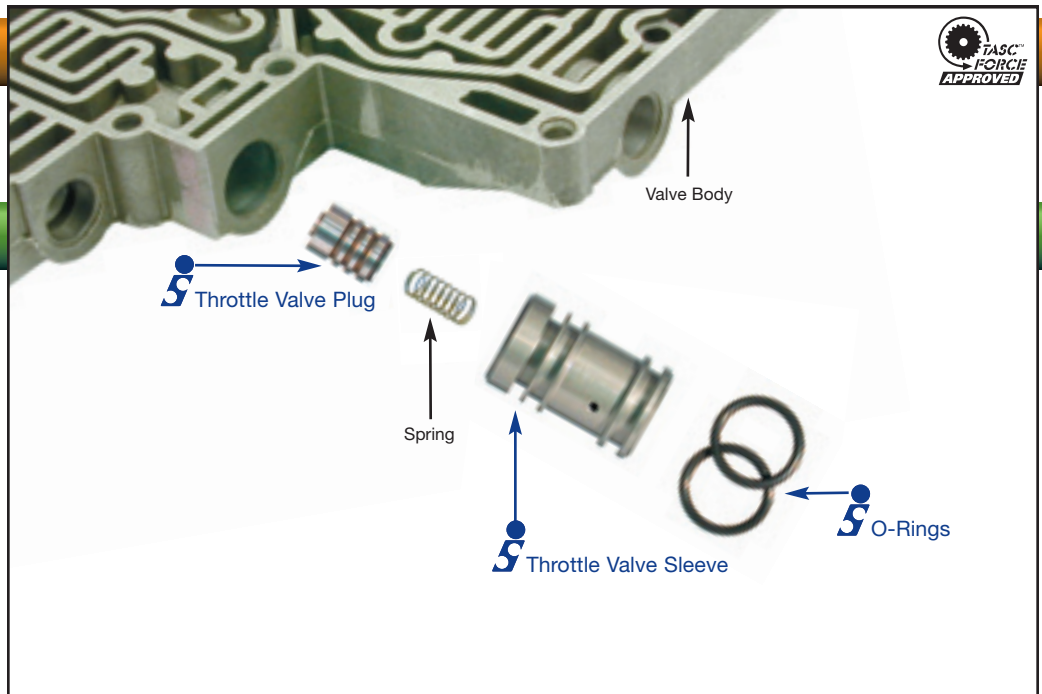
The throttle valve plug wears the sleeve, allowing throttle valve feed oil to leak past the plug and exhaust.

The replacement kit includes a tightly toleranced o-ringed sleeve manufactured to resist excessive wear.
