Oversized Torque Signal Valve

84754-44

Sonnax Part Summary

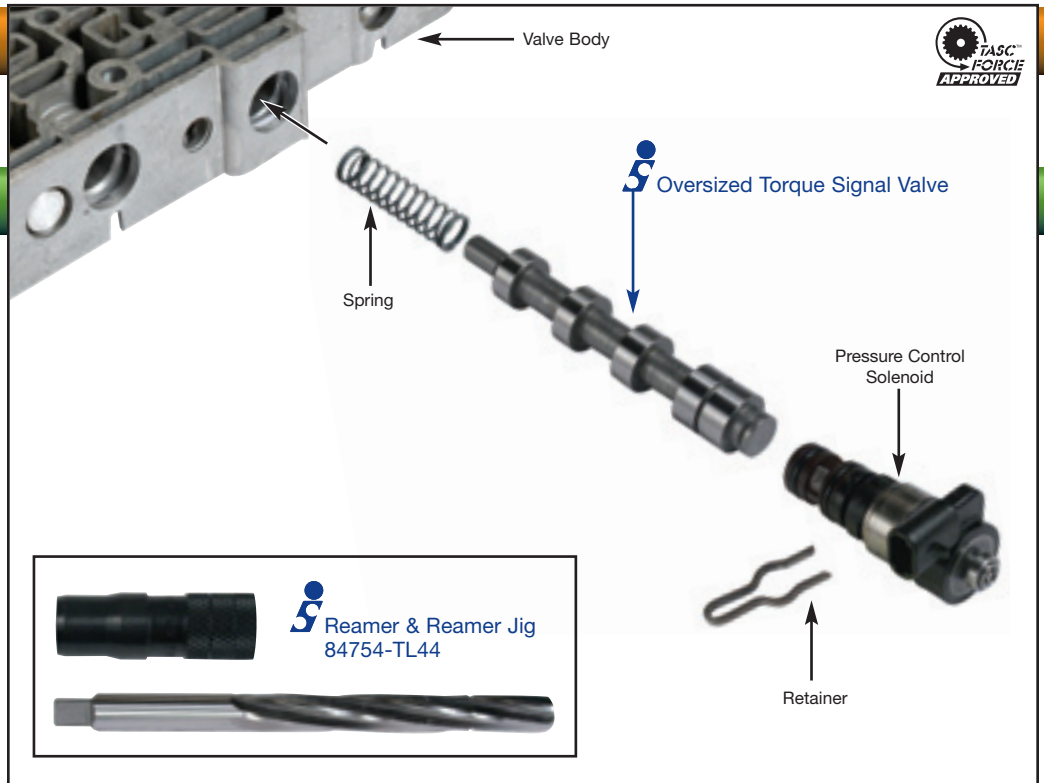
P1811 code, poor or intermittent line rise, slip/shudder condition

• P0741 and P0742 TCC codes

A worn torque signal valve/bore and/or a sticking torque signal valve.

The Sonnax valve and tool allow you to salvage the valve body by oversizing the bore and restoring proper hydraulic clearances.

Note: To eliminate codes 1811 and 741 and TCC-related issues, be sure to also inspect the actuator feed limit valve, boost valve assembly, TCC regulated apply valve and TCC apply valve. The PCM must be reset/relearned after any valve body repairs. Aftermarket scanner relearn procedure or battery disconnect for 12 hours may not restore drivability and line pressure control. Performing a dealer reflash or a web reflash is frequently the only method to properly restore control.
