**Servo Tube
Bracket**

96806

Sonnax Part Summary

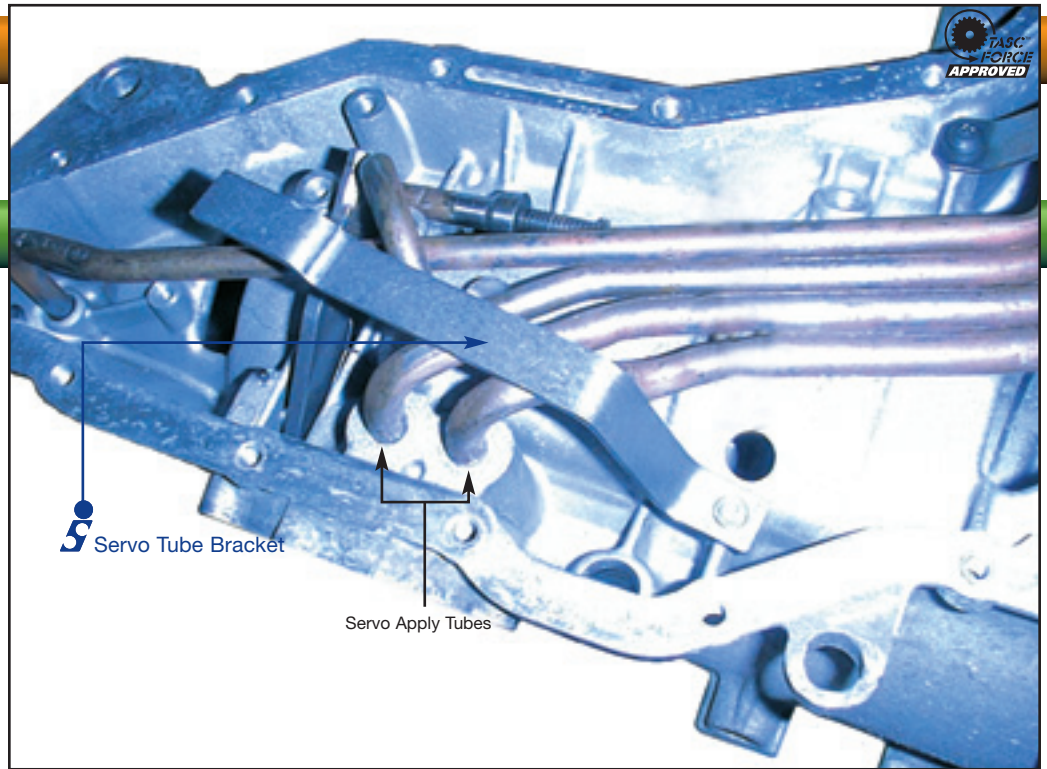
No forward or no 3rd gear

Insufficient factory press fit between the tubes and case results in tube blow-off.

The servo tubes on AXOD & E units may walk off from the transmission case. This causes the servo piston to release and create a no forward condition. There may be insufficient press fit between the tubes and case to withstand the servo apply pressure. If the tubes have been removed for cleaning, the possibility of walk-off increases. Install the Sonnax AXOD & E servo tube bracket **96806**. It is an easy-to-install bolt-on bracket that positively retains the servo tubes.

This bolt-on bracket positively retains the servo tubes, eliminating the chance of blow-off.
