Sonnax Part Summary

Borg Warner 4405 and 4411 transfer cases often exhibit a variety of noise or engagement issues. The three kits offered, **100567A-01K**, **100329-01K** and **100912-01K** each address a problem found in many of these transfer cases.

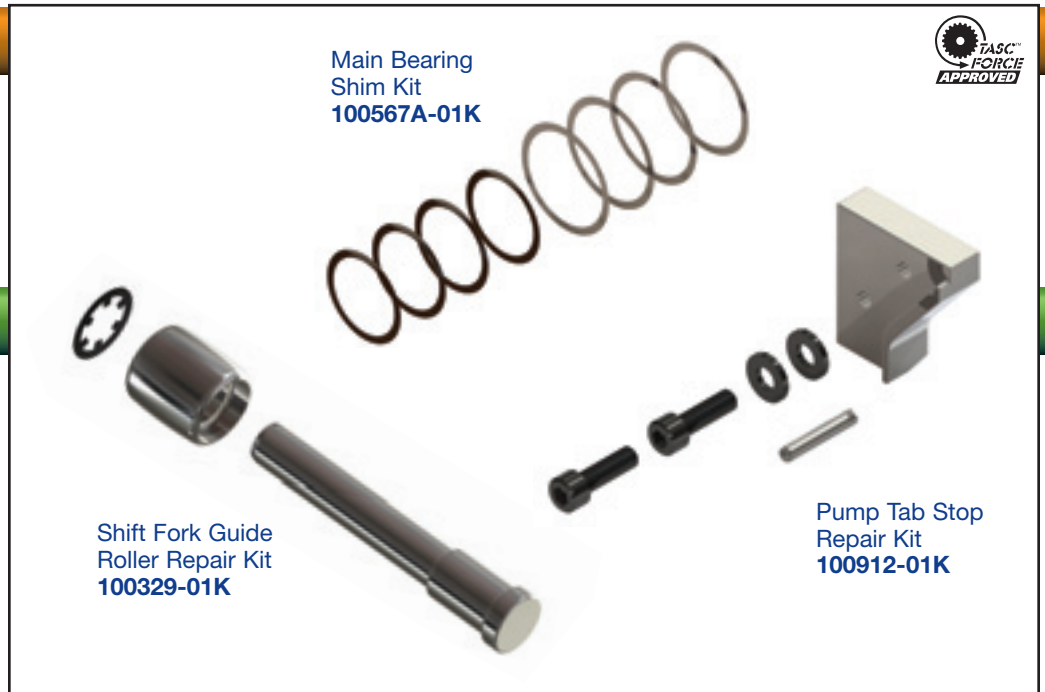
Grinding, clicking, jumps out of four-wheel-drive engagement

- Slotted case
- Worn bearing housing

Minimal OE engagement at roller and control groove allows roller to drop out of groove resulting in loss of four wheel drive. Soft case materials are subject to extreme wear. This wear is visible when the pump tab slots out the case.

The longer pin and roller improve roller engagement with the control groove. Shims reduce bearing shaft end play and the new pump tab stop relocates the contact point.
