AG4 096, 097, 098, 01M, 01N, 01P

PART NUMBER 119905-01K

Bushing & Thrust Washer Kit

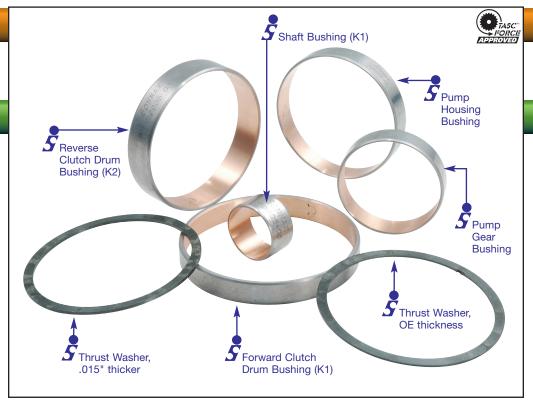
119905-01K

Delayed reverse, low line pressure in reverse

• Clutch failure • Shudder or slip on shift • Low clutch circuit pressure

Worn bushings and poor sealing ring performance associated with excessive clutch drum run-out and instability.

The Sonnax precision bushings are designed to have tighter clearances for better drum stability and improved circuit integrity.
