096, 097, 098, 01M, 01N, 01P

PART NUMBER 119940-23

Manual Valve Operating Rod

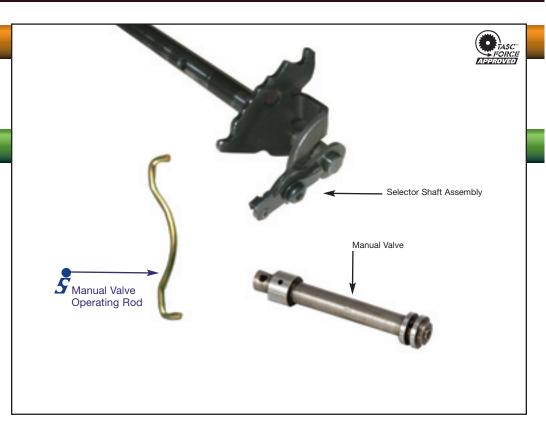
119940-23

Loss or bending of operating rod

The manual valve operating rod can become lost or damaged during a rebuild, making it necessary to rob cores for replacement parts.

Sonnax has developed a direct replacement manual valve operating rod to prevent scrapping of expensive cores.

The operating rod (linkage) that connects the selector shaft assembly to the manual valve is often lost or damaged during overhaul. This direct replacement manual valve operating rod is made from hardened steel wire to ensure the proper geometry is retained, and allows units to be salvaged.
