Pump Stator Bushings

120003K

Sonnax Part Summary

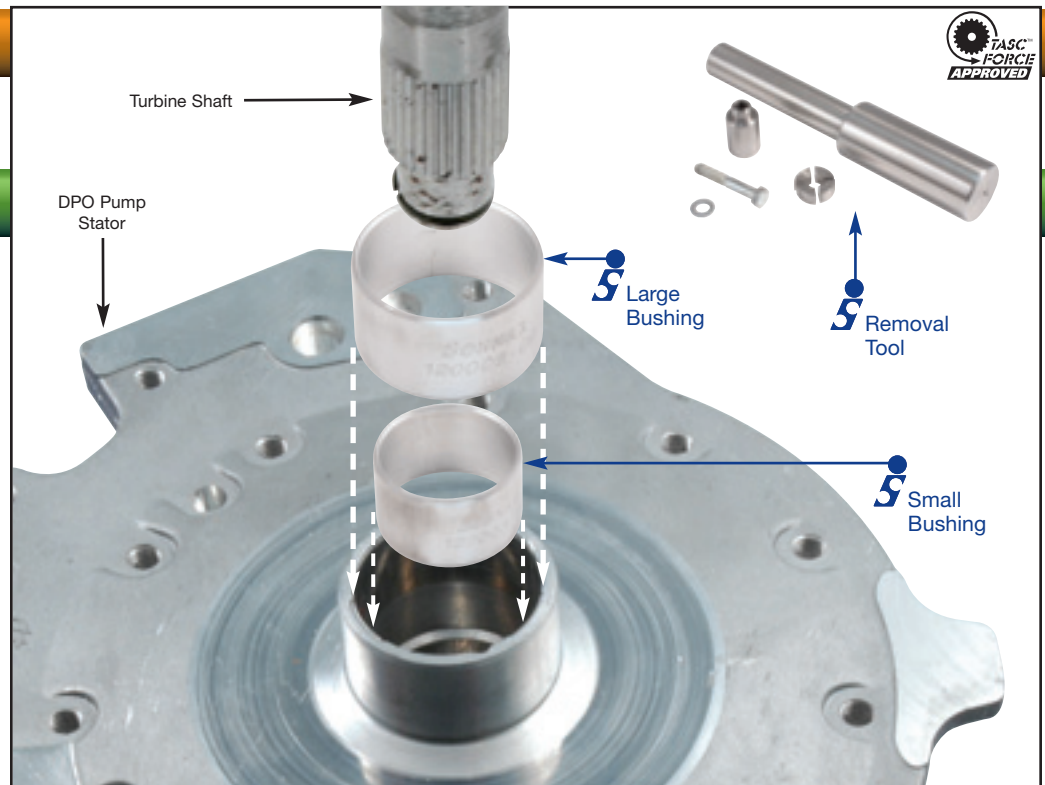
Pump stator bushings worn beyond service limits

- Excessive turbine shaft-to-stator bushing clearance

Wear associated with normal use causes bushing failure.

The Sonnax bi-metal bushing restores correct shaft/bushing clearance and resists wear.

Note: This tool will remove pump stator bushings from both Renault DPO and Citroen AL-4 transmissions without damage to the bore.
