Wide Front Stator Support Bushing

34016-W

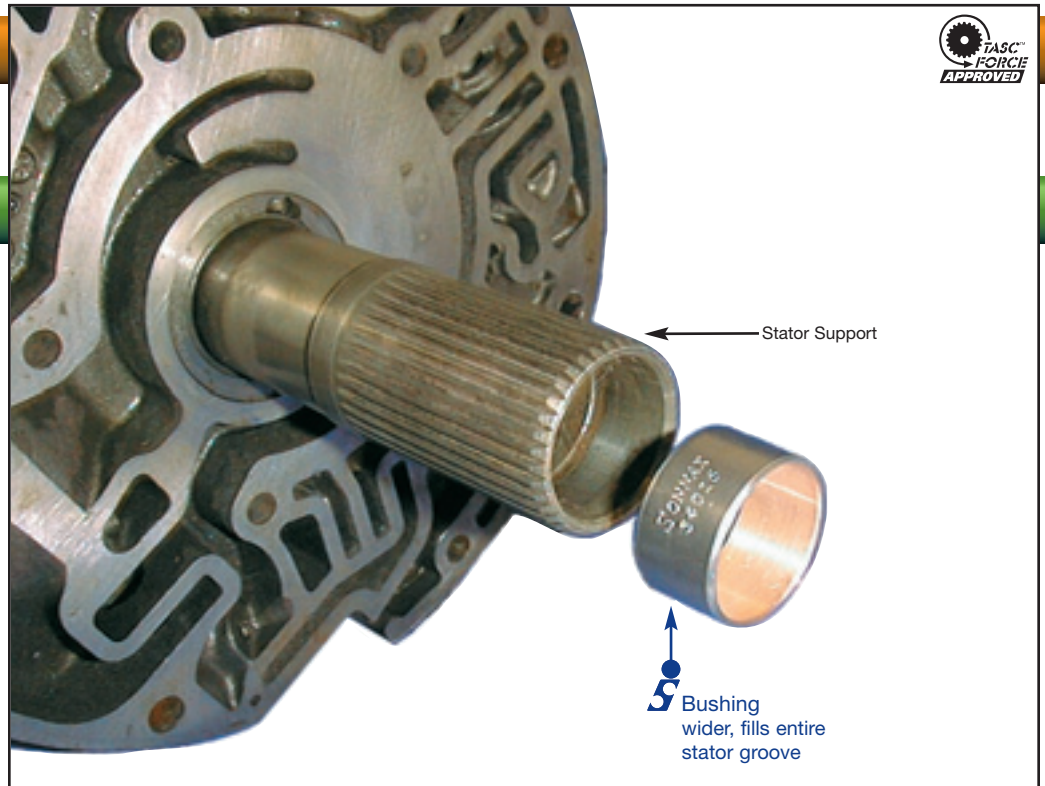
No lockup or TCC slip codes

- No overdrive • Overheated fluid

TCC apply oil leaks past the front stator support bushing.

4L80-E units may display no converter lockup or codes 68, 39, 1870 or P0741. Imbalance of torque converter clutch apply oil through the front stator support bushing contributes to this complaint. A journal clearance of .002" or more will generate sufficient leakage to cause lockup clutch slippage, causing the transmission to stay in third gear. Replace the worn-out bushing with Sonnax's 4L80-E front stator support bushing **34016-W**.

This wide front stator support bushing fills the entire stator support shaft bore.

- Replacement bushing is designed to reduce leakage by minimizing journal clearance and also increasing journal length.

Note: In some cases it may be necessary to hone the bushing I.D. slightly for proper fit due to stator shaft variations. Hone I.D. to .001" overall clearance with the input shaft.
