Reverse Boost Valve & Sleeve

34910-01K

Sonnax Part Summary

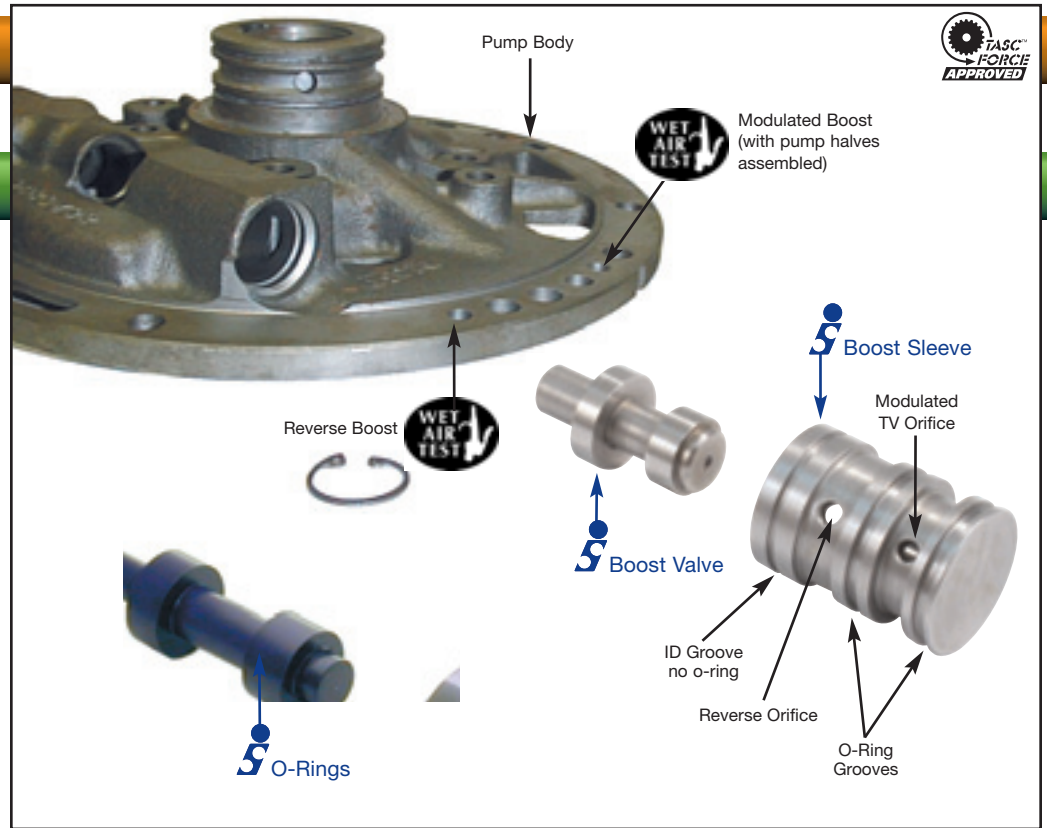
Soft 1-2 and 2-3 shifts, delayed reverse

- Poor line rise • Reverse shudder

A worn boost sleeve.

Vehicles with a THM 400 transmission frequently have poor line rise, soft 1-2 and/or 2-3 shifts, and/or reverse engagement difficulties. These problems can be caused by the reciprocating reverse boost valve wearing the inside diameter of the boost sleeve. When this occurs, oil that enters the modulated throttle valve orifice leaks past the boost valve and exhausts through the reverse orifice or to the sump, resulting in poor line rise. Also, reverse oil can exhaust both to the sump and back through the modulated TV orifice. The outside diameter of the boost sleeve also allows some leakage through the pump body, which can increase boost oil loss. The Sonnax replacement assembly 34910-01K eliminates the above problems.

The Sonnax assembly restores hydraulic integrity and provides a positive seal with the pump bore.
