"Factory" Style Boost Valve Kit

34910-05K

Sonnax Part Summary

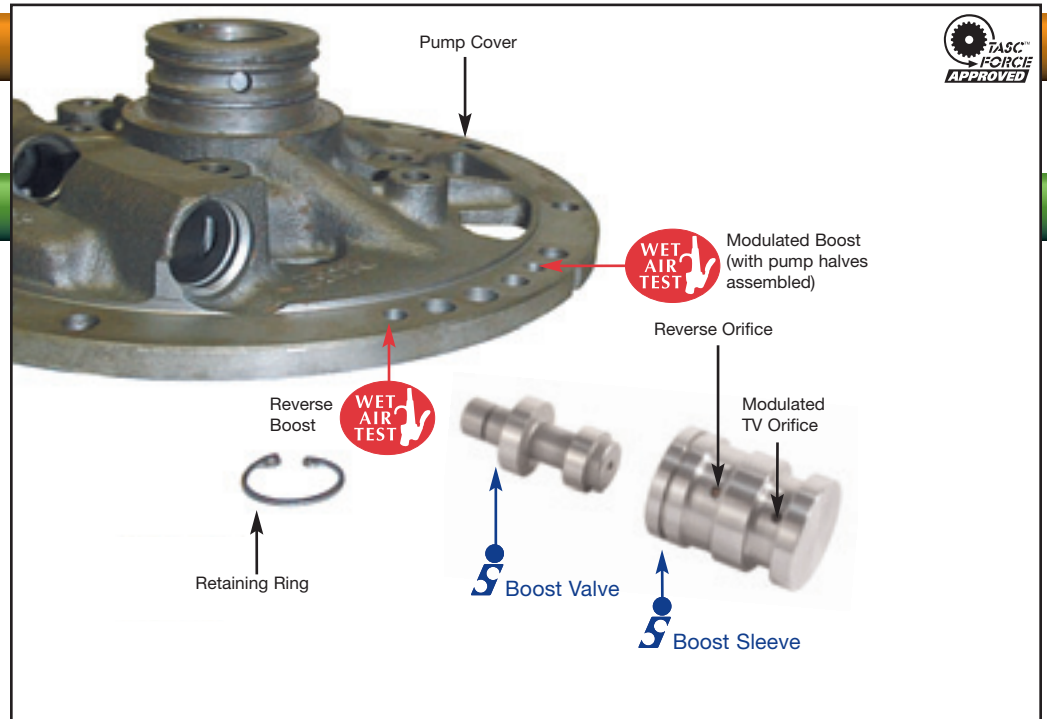
Soft 1-2 and 2-3 shifts, delayed reverse

- Poor line rise • Reverse shudder

Wear of the sleeve ID due to continuous oscillation of the boost valve.

Vehicles with a THM 400 transmission frequently have poor line rise, soft 1-2 and/or 2-3 shifts, and/or reverse engagement difficulties. These problems can be caused by the reciprocating reverse boost valve wearing the inside diameter of the boost sleeve. When this occurs, oil that enters the modulated throttle valve orifice leaks past the boost valve and exhausts through the reverse orifice or to the sump, resulting in poor line rise. Also, reverse oil can exhaust both to the sump and back through the modulated TV orifice. The Sonnax replacement assembly **34910-05K** eliminates the above problems.

The "factory" style Sonnax assembly restores hydraulic integrity with closely toleranced parts.

- Boost valve and sleeve are manufactured from high-quality steel.
- Sonnax kit **34910-05K** uses the same valve spool diameters as the OEM version to regain factory shifts.
