## Delayed forward or reverse engagement, worn accumulator bore

## 1-2 Accumulator Sleeve Kit

### 35719-01K

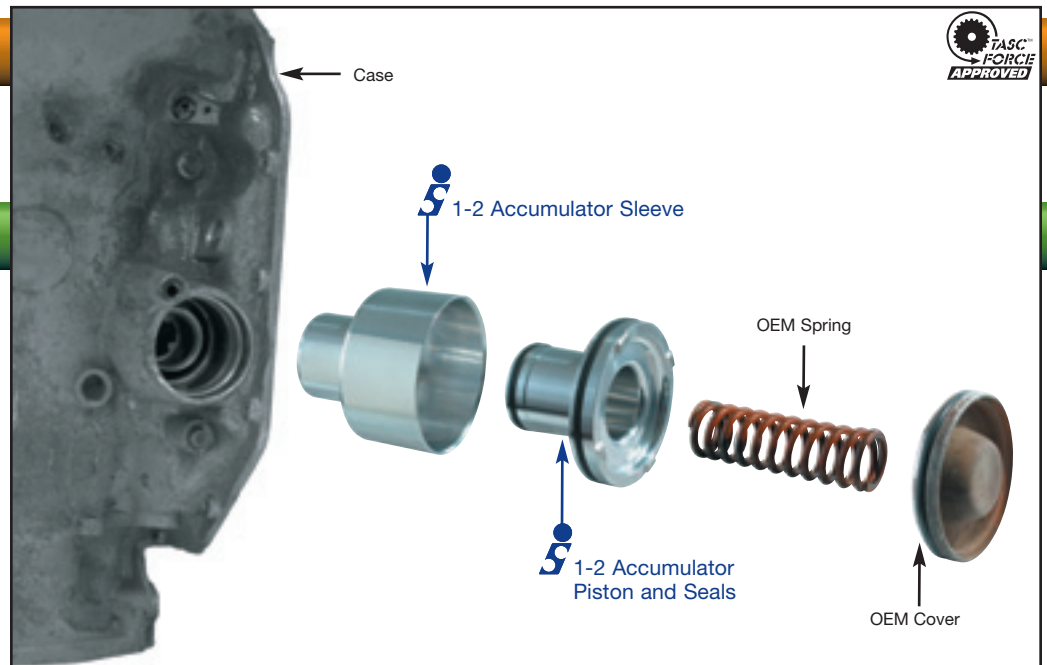
The 1-2 accumulator bore becomes worn or scored from repeated oscillation during normal operation.

The 1-2 accumulator bore in the 350 cases can become worn or scored from repeated oscillation during normal operation. This can result in delayed engagements and 1-2 slip from low line pressure, which could cause intermediate clutch failure. Once the bore is damaged the case must be thrown away. Sonnax has designed a 350 1-2 accumulator sleeve rebuild kit **35719-01K**, which contains everything necessary to rebuild your 1-2 accumulator, except for the OEM spring, snap ring and cap.

This drop-in sleeve and sealed piston kit restores hydraulic integrity and saves worn cases.
