E40D 4R100 ('89 & UP)

PART NUMBER 36744-01

Overdrive Piston Return Spring Retaining Ring

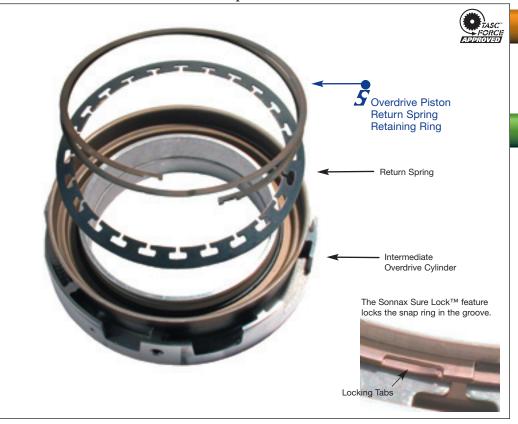
1 Overdrive Piston Return Spring Retaining Ring

Overdrive piston retaining ring pops out of groove

• E4OD, overdrive is lost • 4R100, catastrophic failure

The open-end style retaining rings do not have a locking mechanism, and are susceptible to being pulled out of groove by piston spring forces.

The Sonnax Sure LockTM retaining ring is mechanically locked in place and cannot come out.
