**COMPLAINT**

**Code 872, 3rd gear start**

**E-Shift Valve Spring & Bore Sizing Tool**

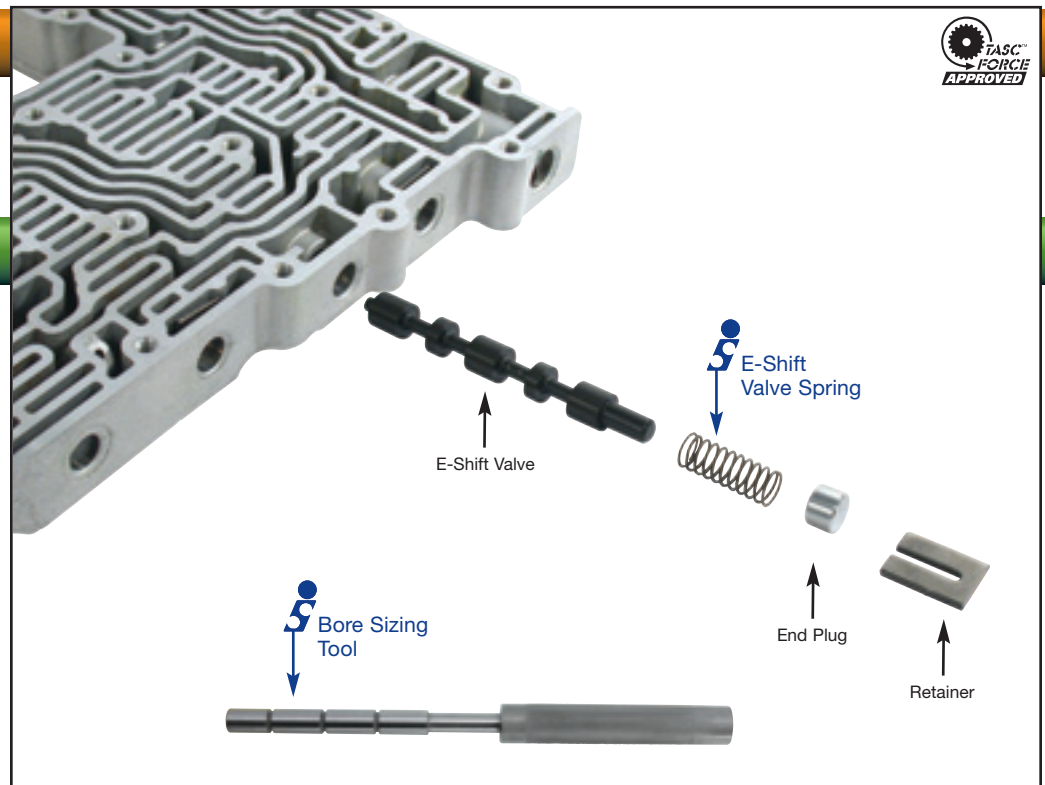
Excessive flashing on the valve body casting, an out-of-round valve bore and low return spring rate can cause the E valve to stick.

A sticking E-shift valve in an Allison series unit can be caused by a weak spring, an out-of-round valve bore, or excessive flashing on the valve body casting. The Sonnax E-shift valve spring has a higher spring rate than the OEM while the bore sizing tool allows you to improve bore roundness and remove excessive flashing.

Install the stronger Sonnax E-shift valve spring after resizing or realigning the bore to prevent valve hang-ups.

**Note:** Use of the bore sizing tool is not required but is recommended.
