TCC Accumulator Springs

44912-01
5 Springs

Sonnax Part Summary

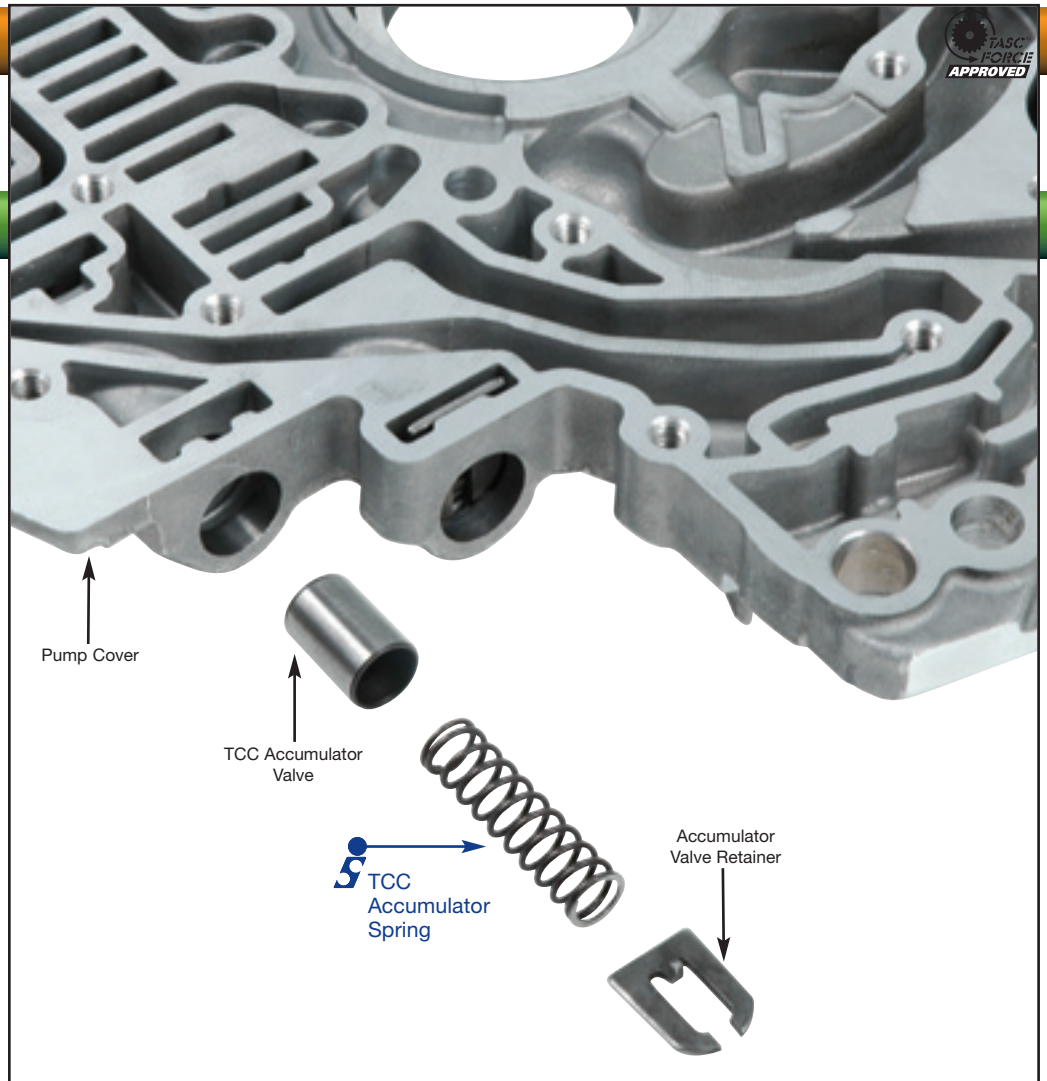
Harsh TCC engagement

The OEM TCC accumulator spring can fatigue or break due to stress and material quality.

Harsh TCC engagement complaints can occur due to breakage of the TCC accumulator spring in the pump assembly. The OEM spring material and design is overstressed in this application. The replacement Sonnax spring **44912-01** is manufactured from an upgraded material to increase spring strength and resiliency.

The Sonnax spring is manufactured from an upgraded material to increase spring strength and resiliency.
