COMPLAINT

Turbine Shaft Stator Bushings

46000-01K

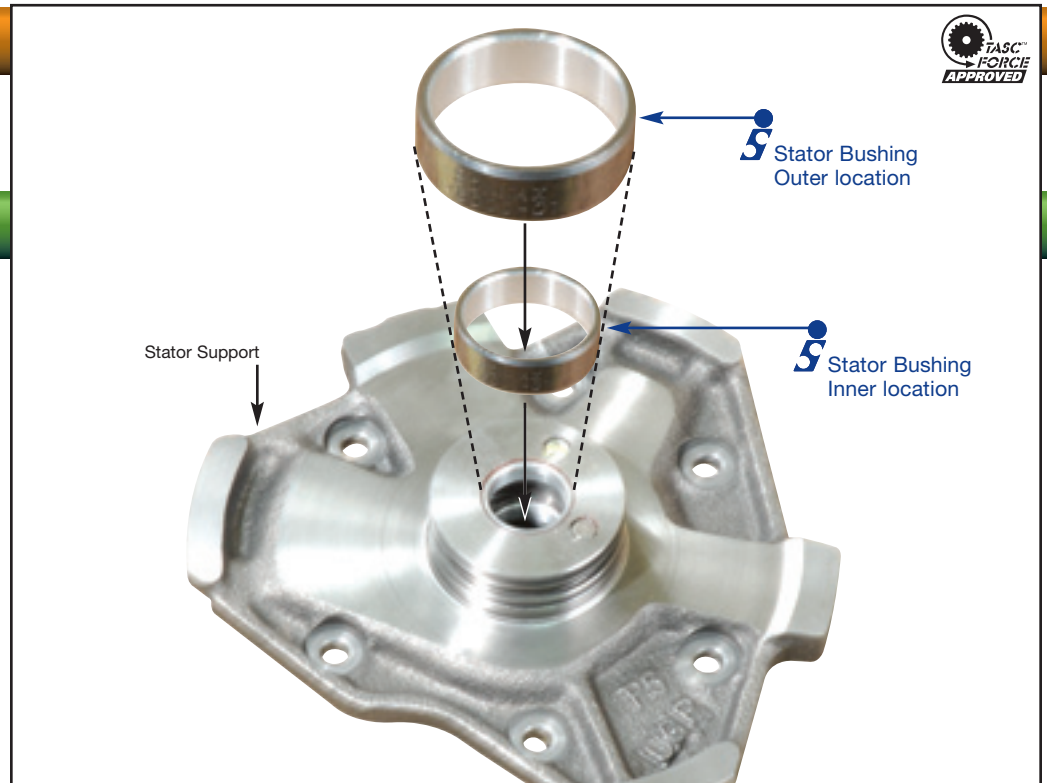
2 Turbine Shaft Stator Bushings

Vehicle exhibits trouble code P0741 TCC stuck "off"

- High TCC slip rate (TCCMACT) increases with operating temperature due to apply oil loss

Worn stator bushings allow TCC apply pressure to exhaust through the already exhausting TCC release passages.

The tightly toleranced Sonnax bushings restore proper clearances.
