# .30-E (PWM ONLY) 2000-U

**PART NUMBER 54754-02**

# 1870 TCC slip code, torque converter slip-related problems

## **TCC Regulator** Valve Sleeve

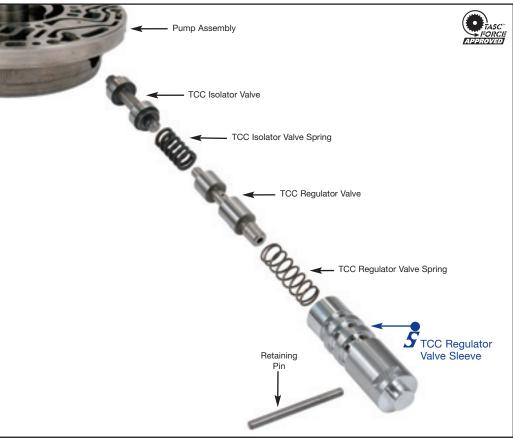
The OEM sleeve warps due to large slots, causing the valve to bind up, or leakage occurs due to sleeve wear, resulting in loss of any pressure.

• Valve stuck in sleeve • Worn sleeve

The OEM TCC regulator valve sleeve is prone to warping because of the large slots on both sides of the sleeve. Once warped, the valve binds and gets stuck in one position or leads to excessive bore wear and circuit leaks. The Sonnax sleeve 54754-02 has reinforcement ribs for added stability and is made from wear-resistant aluminum alloy material. The sleeve is designed for use with the OEM steel valve. This sleeve is a drop-in replacement and does not require machining.

Replace the OEM sleeve with the Sonnax sleeve, which provides added stability and better wear resistance.
