## Sticking governor, bronze in the pan

## Late Model Low Sprag Update

### 56600B-01K

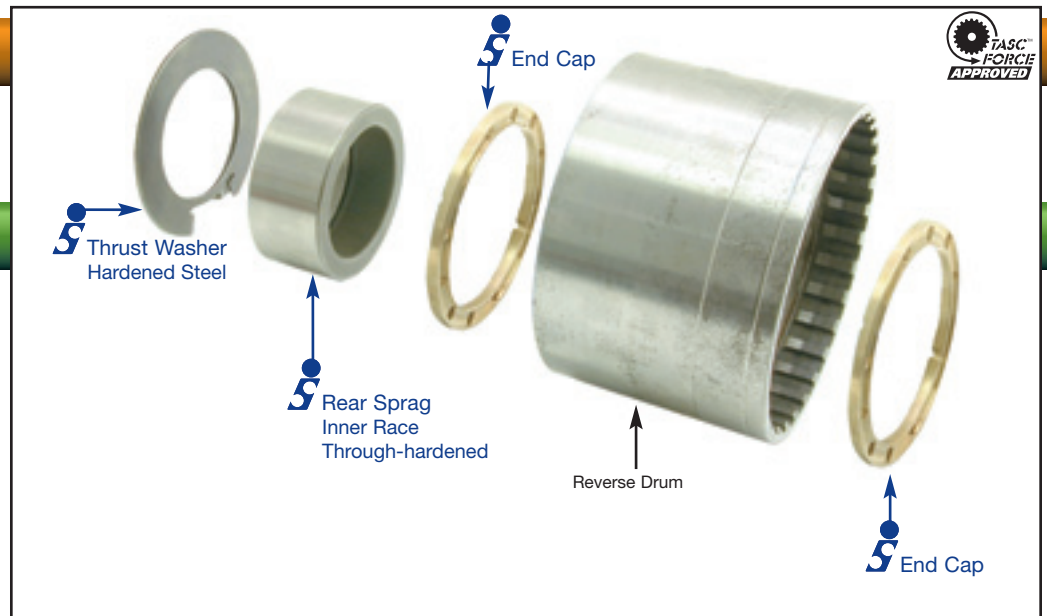
• Sprag thrust washer failure • Damaged case

The steel wave thrust washer and bronze “scoop” washers flex and contaminate the unit with metal.

This kit salvages cases, prevents future metal contamination from worn washers, and has an upgraded inner race.
