## Insufficient line rise in drive ranges

## Boost Valve Assembly

### 57917E-01K

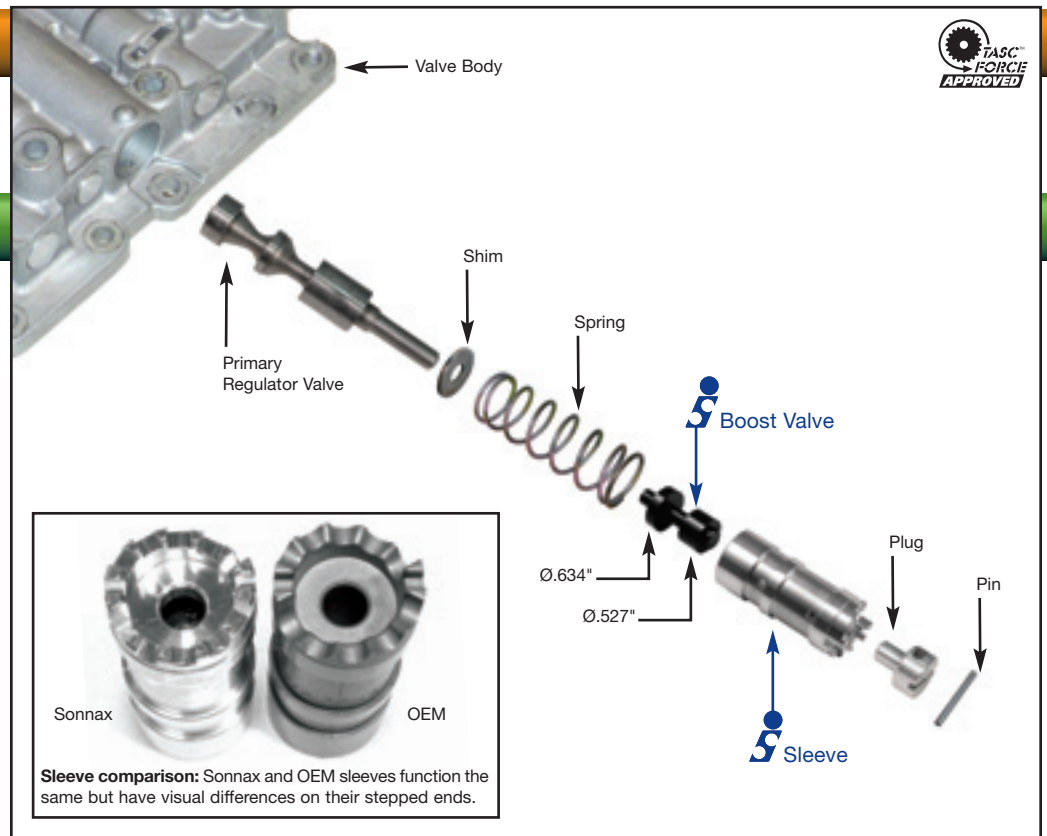
These problems can be caused by severe wear of the boost valve sleeve, allowing EPC and reverse oil leakage.

Toyota vehicles with a U241E transmission may exhibit insufficient line rise in the drive ranges and excessively high pressures in reverse. This may be caused by continuous oscillation of the steel boost valve within the cast-aluminum sleeve, creating excessive wear and a path for EPC and reverse pressures to leak. The Sonnax replacement boost valve assembly, 57917E-01K, has upgraded materials and minimal clearances to prevent wear and restore proper hydraulic control.

The Sonnax boost valve assembly has upgraded materials and minimal clearances to prevent wear and restore proper hydraulic control.

- Boost sleeve manufactured from highly wear-resistant billet aluminum to prevent the excessive wear exhibited by the cast OEM sleeve.
- Salvages expensive valve bodies.
- Restores proper line rise.
