Solenoid Modulator Valve Kit

57917E-13K

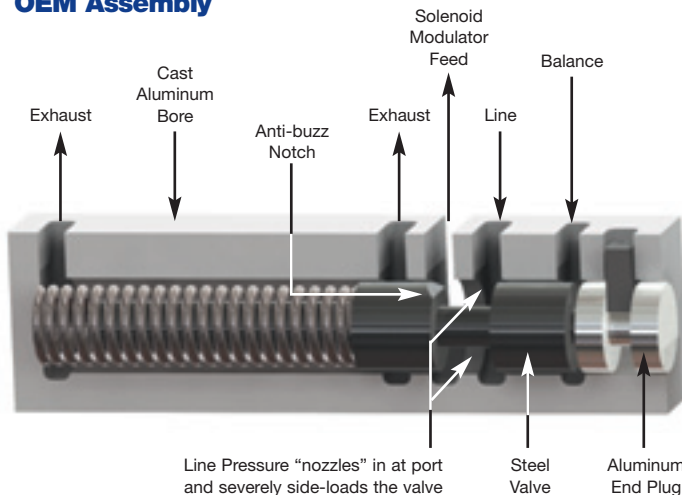
OEM Assembly

Excessive solenoid pressure is caused by line pressure side-loading the steel solenoid modulator valve and the continuous oscillation of the valve, which wears the cast aluminum bore.
