Solenoid Modulator Valve Capsule

59947-09K

Note: Also fits AW55-51SN, AF 23/33 and RE5F22A units.

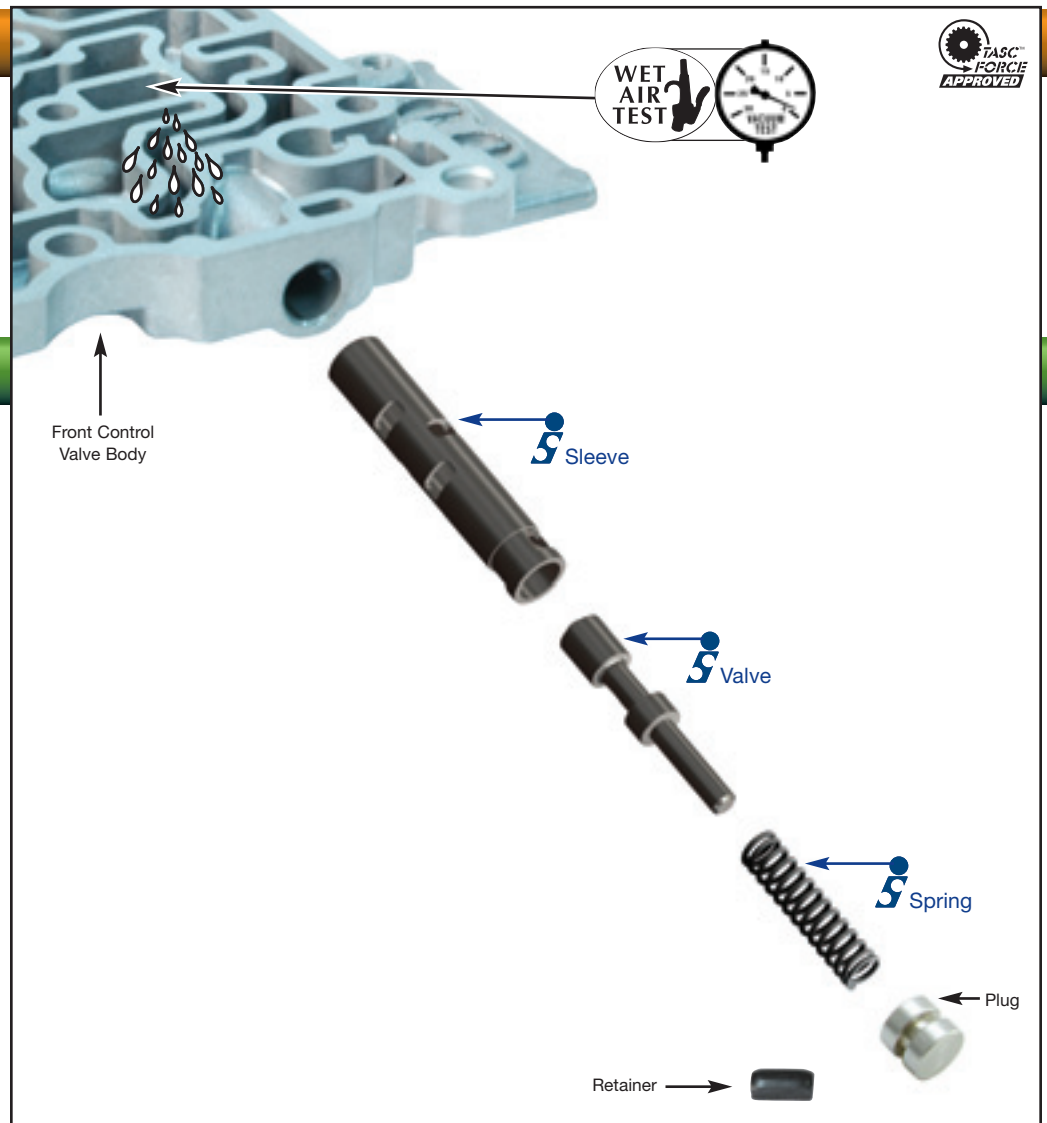
Loss of 3rd, 4th and 5th gear, no TCC apply

- Low line pressure • Delayed forward • 2-3 flare upshifts • 5th gear only condition

The OEM steel valve results in excessive clearance during hot operation and frequently sticks when cold. Bore wear can reduce available solenoid modulator pressure, resulting in delayed forward, flare on 2-3, TCC slippage or soft shifts overall. Bore wear at the inboard end results in excess solenoid pressure, improper gear or harsh shifts.

The steel drop-in-place capsule contains a tightly toleranced sleeve and valve designed to prevent wear and re-establish correct hydraulic clearances and valve operation without the need to oversize the existing cast bore.

- Capsule is a drop-in-place fix, requiring no tooling.
- Case-hardened steel valve and moderately hard sleeve prevent future wear.
- A replacement spring is included to set the solenoid modulator feed pressure back to OEM specifications.
- Orifice plugs provided for separator plate modification.

A Wet Air Test in the location indicated with the valve blocked inward results in leakage out the neighboring line port, or a vacuum test of the balance port gives less than 18" of vacuum.
