## **AW50-40LE/42LE**

PART NUMBER 59954-01K

# Lockup Control Plunger & Sleeve Kit

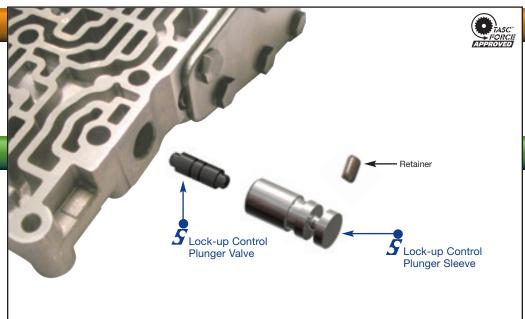
Continuous oscillation of the steel lockup control plunger valve wears the inside of the aluminum sleeve bore, allowing converter apply pressure to exhaust and preventing proper control of the lockup control valve.

### TCC apply/release problems

• Converter codes • Burned converters

The tightly toleranced, drop-in replacement Sonnax valve and sleeve assembly restores proper hydraulic clearances and uses upgraded materials to prevent wear.

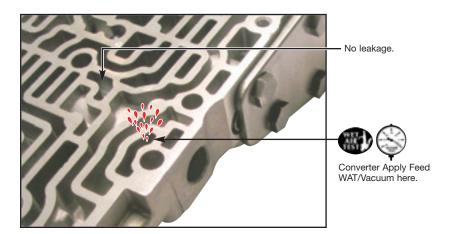
A vacuum test of the sleeve assembly (while in the bore at the outboard converter apply feed port as indicated) gives less than 18" of vacuum, or if a Wet Air Test at the same location results in leakage at the neighboring exhaust port.
