Oversized Pressure Regulator Valve & Reverse Boost Assembly

63741-01K

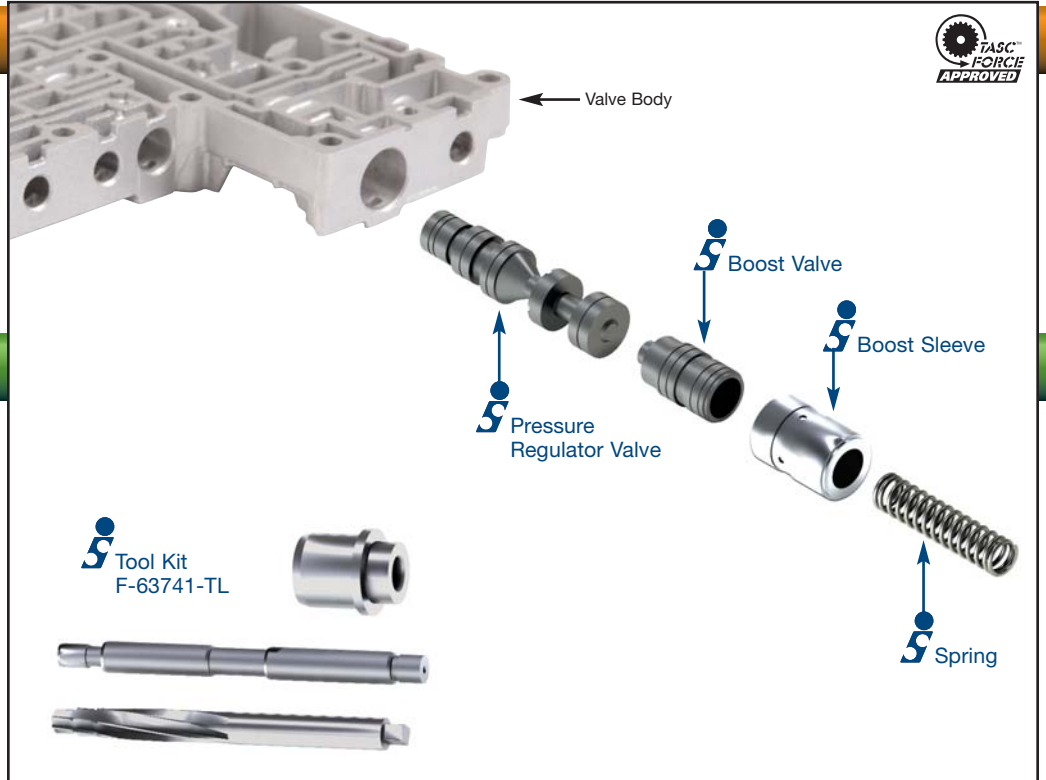
Wear at the balance spool can cause harsh shifts, high line pressure, converter apply/release problems and lube related issues. Wear at the cutback spool location can also result in high pressure and harsh shifts. A worn boost sleeve in this unit can cause a delay in reverse or slippage, eventually burning the Low Reverse band and or the Direct clutch.

The Sonnax kit includes an oversized pressure regulator valve to restore correct clearances for proper hydraulic control and a replacement reverse boost valve assembly.

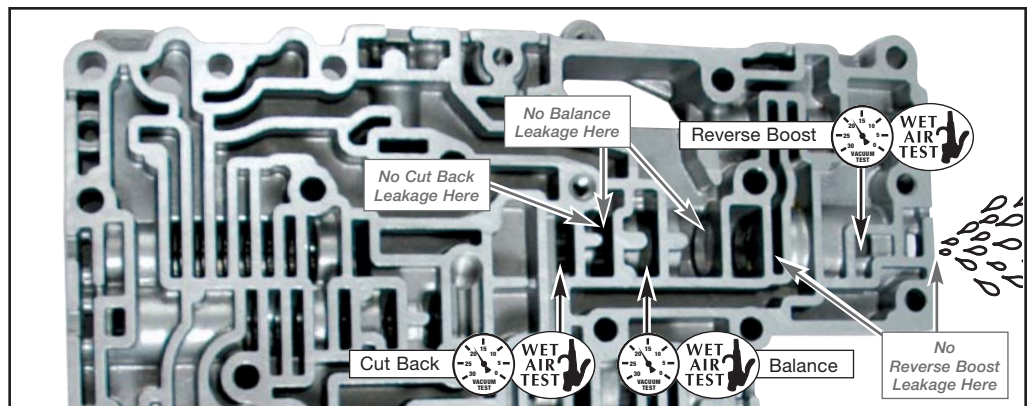
Either a Wet Air Test or a Vacuum Test in the location shown, results in leakage. A vacuum test must hold a minimum of 18".
