Accumulator Control Valve Kit

63741-20K

Notes: Fits Nissan, Infinity RE5R05A and Kia A5SR1/A5SR2.

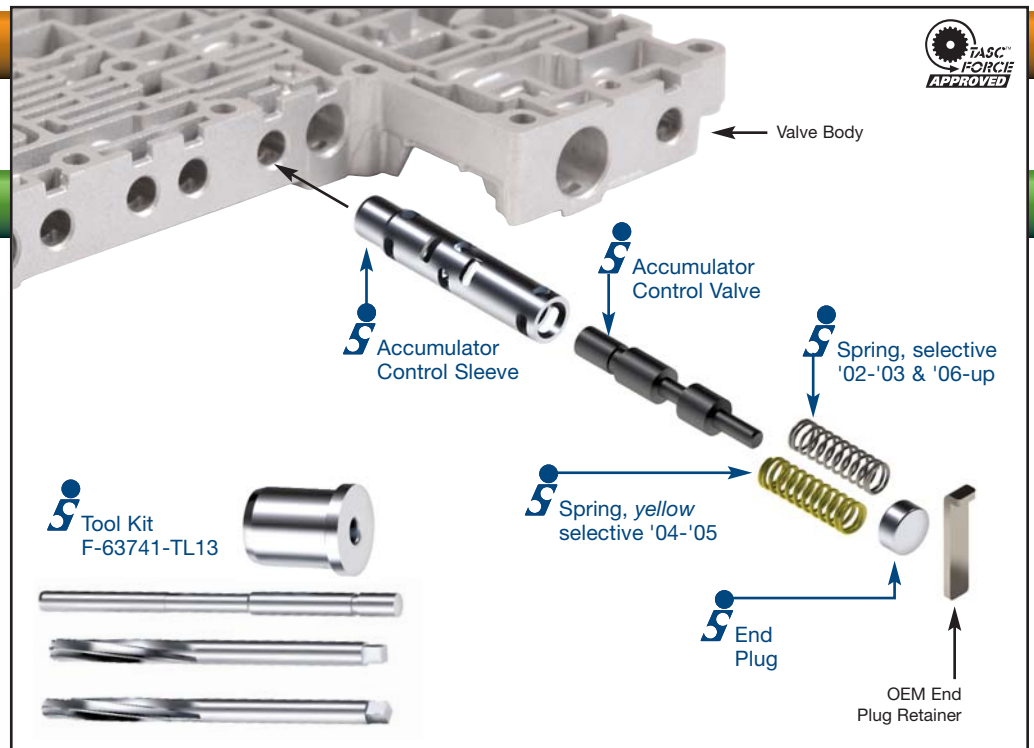
Severe bore wear at the accumulator control valve bore.

Severe wear of the Accumulator Control valve bore results in leakage of accumulator oil pressure that compromises shift timing and feel, resulting in shift feel complaints. The Accumulator Control Valve kit **63741-20K** restores proper accumulator oil pressure, salvaging these valve bodies.

Enlarge the bore and install the Sonnax wear-resistant sleeve and replacement valve assembly. Select and install one of the calibrated springs, then finish with the oversized end plug.

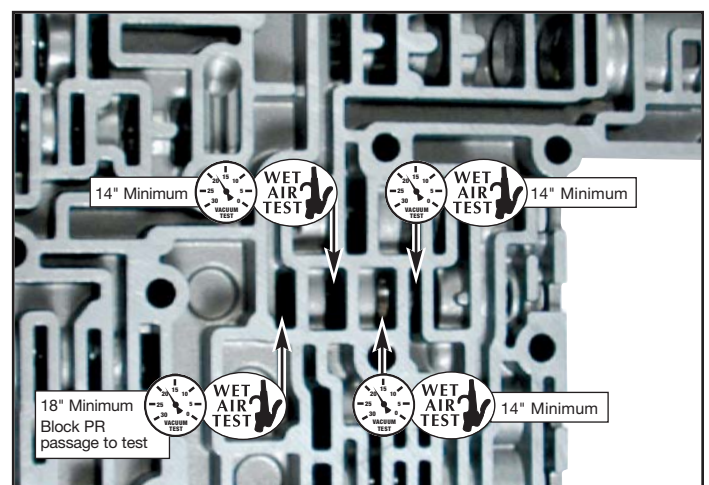
Either a Wet Air Test or a Vacuum Test in the location shown, results in leakage. A vacuum test must hold a minimum of 14" or 18" as labeled.
