Accumulator Shift Valve

63940-03K

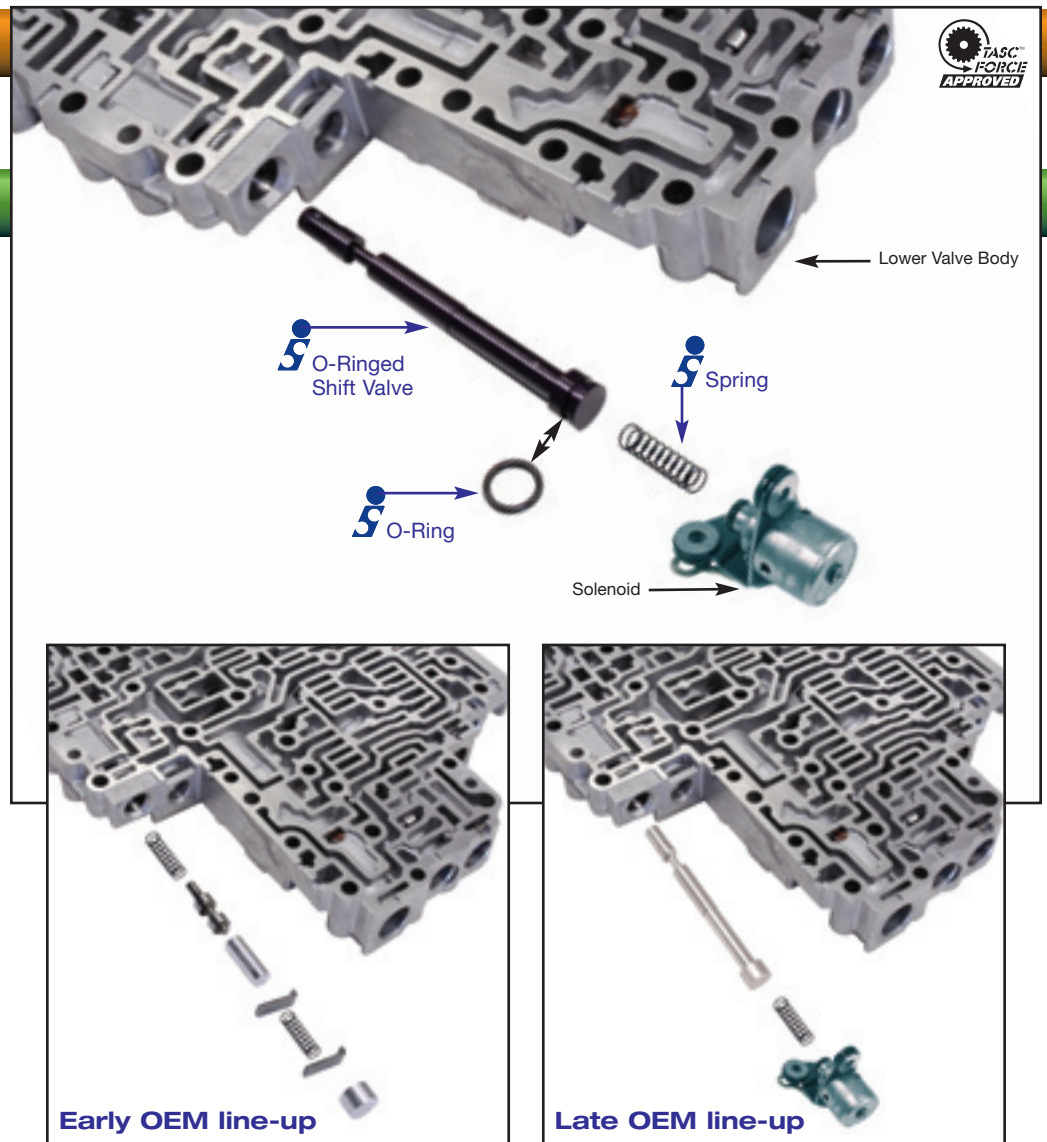
Premature clutch/band failure, poor reverse boost

- Soft shifts • Insufficient line rise • Erratic buzz or uncontrollable pressure in reverse

An out-of-position accumulator shift valve creates soft or flared upshifts.

The accumulator shift valve line-up has been changed numerous times by OEM, and incorrect reassembly can result in soft or flared upshifts. This kit includes an accumulator shift valve that will be correctly positioned to prevent soft or flared upshifts.

This updated design eliminates the OEM split valves and seals all circuits.

Note: Replaces early or late OEM line-ups in most valve bodies. Some late valve bodies do not have an accumulator shift valve.
