## COMPLAINT

## Outer Pressure Regulator Sleeve

**68942-06**

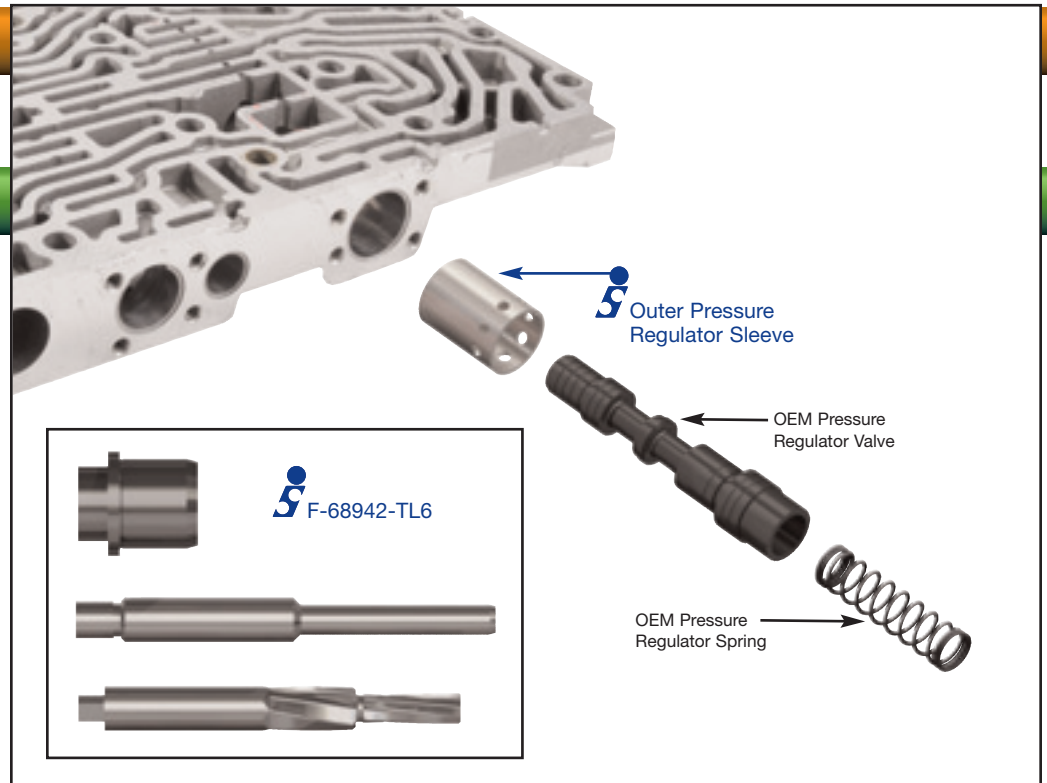
**F-68942-TL6**

A worn pressure regulator bore at the modulating pressure spool area.

Excessive valve-to-bore clearance at the modulating pressure area allows modulated solenoid feed pressure to exhaust, reducing line pressure and creating shift-related complaints. The Sonnax sleeve **68942-06** salvages the valve body with a precision-machined, wear-resistant aluminum sleeve.

The Sonnax pressure regulator sleeve salvages the worn valve body by restoring the modulating pressure bore area.
