Oversized Manual Valve

68942-16

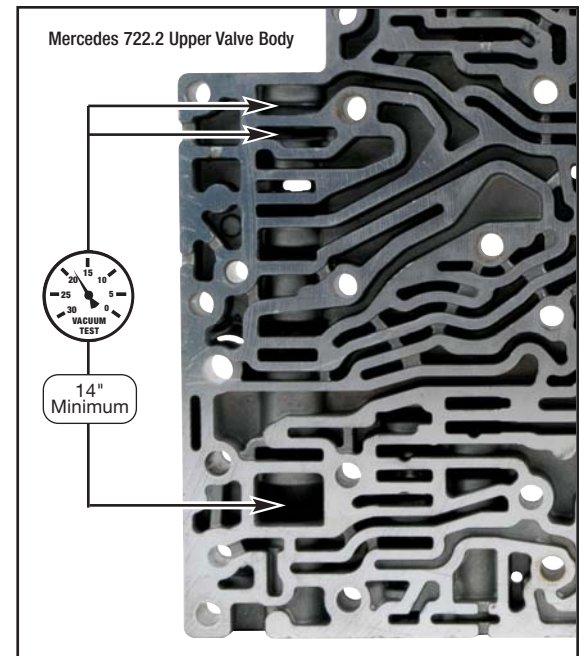
Reduced line pressure, delayed drive/reverse engagement

Valve and/or bore wear due to linkage side loads and/or extended service life.

A Vacuum Test in the locations shown, result in leakage. A vacuum test must hold a minimum of 14".

Ream the bore oversize and install the new Sonnax oversized manual valve.
