## Boost Valve Assembly

### 72754-01K

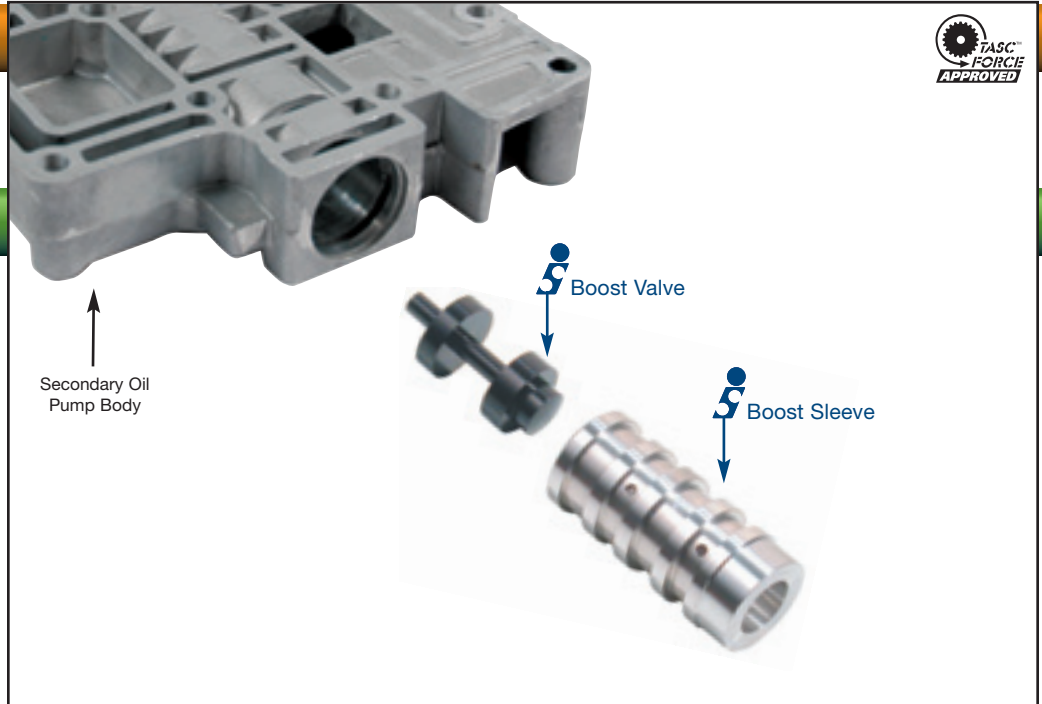
A worn boost valve sleeve allowing torque signal and/or reverse pressure to cross leak or exhaust can cause these complaints.

The boost valve assembly is activated by torque signal pressure from the pressure control solenoid and reverse pressure to aid in adjusting line pressure at the pressure regulator valve. This boost valve is continuously oscillating in the sleeve, which leads to wear and hydraulic leakage. When wear occurs, critical oil pressure is allowed to cross leak between the circuits or leak to exhaust. These leaks can result in either no line rise or an unwanted increase in line pressure.

This replacement boost valve assembly restores hydraulic integrity to the circuits and properly controls line rise.

Sonnax now offers a replacement boost valve assembly **72754-01K** that restores hydraulic integrity and properly controlled line rise. The sleeve is manufactured from highly wear resistant aluminum, and the valve from anodized aluminum. Tight tolerances on the sleeve and valve maintain an ideal fit that prevents leakage.
