CD4E, LA4A-EL

PART NUMBERS 73840-BK, -BTL

Bypass Clutch Control Kit

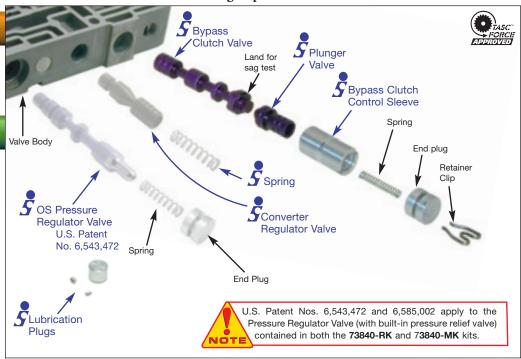
Casting bore wear at the bypass clutch valve and plunger sleeve wear allow converter apply and release pressure to exhaust.

Codes 628/1744/1740, lube oil loss

• Reduced converter clutch life • Bushing or planet failure

The Sonnax reamer restores the bypass clutch control bore while the OS valve re-establishes bore fit and extends life through additional spool support and annular grooves.
