Wiring Harness Connector Bracket

73949-01

Sonnax Part Summary

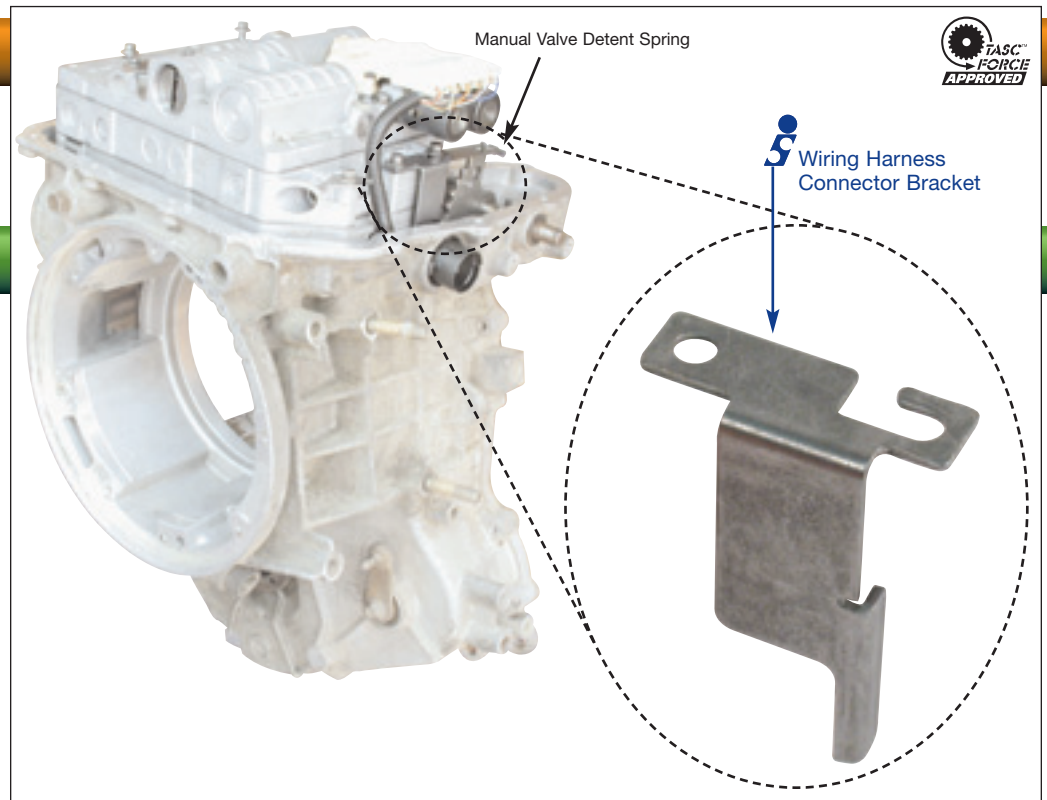
Broken retaining tabs on wiring harness connector

- Connector pushes into transmission case

The plastic retention tabs that hold the wiring harness connector in place are easily broken. Once broken, the connector may push into the case.

The Sonnax metal bracket positively supports the connector and prevents it from pushing into the case even if the plastic retention tabs are broken.

- Bracket connects to existing hardware inside the oil pan using existing bolts and holes.
- Holds connector firmly in place.
- Can be installed without having to remove solenoids or valve body.
- No modifications to transmission necessary.
