COMPLAINT

Boost Valve Kits

Sonnax Part Summary

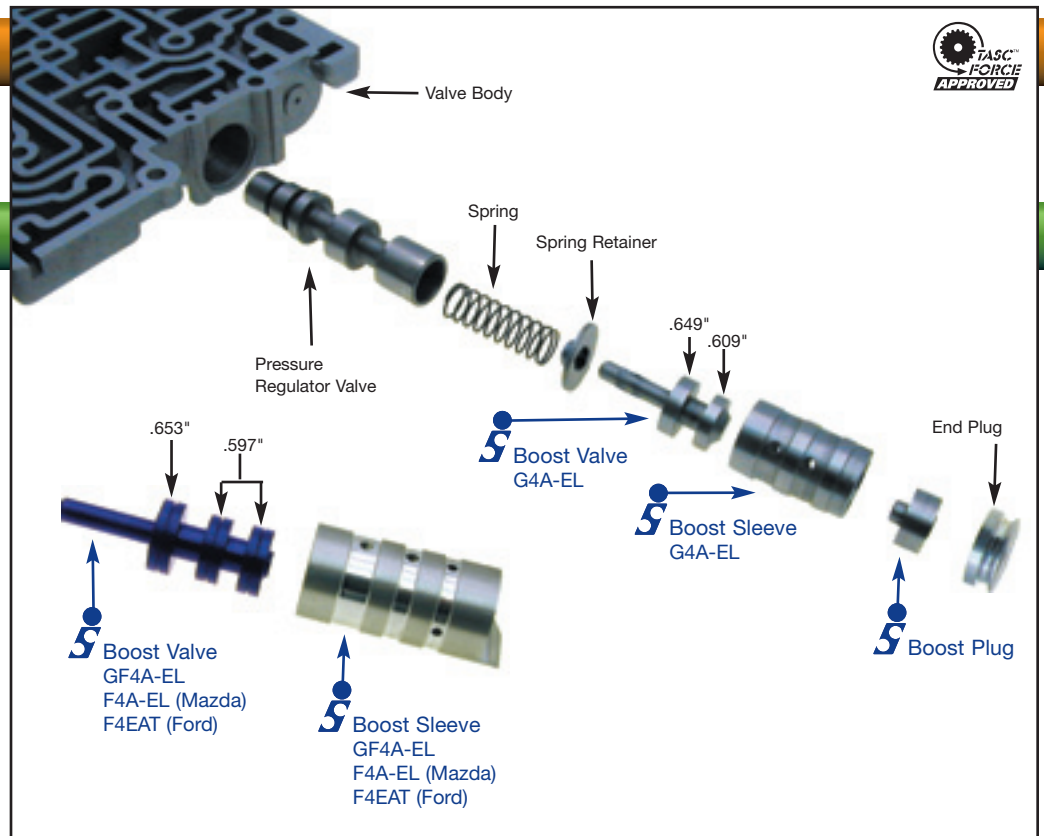
Low line rise

- Low reverse boost and shudder • Delayed reverse • Poor 1-2 shift

Worn boost valve sleeves allow EPC, TV boost or reverse pressures to cross leak into exhaust.

These replacement boost valve kits are hardened and anodized to prevent wear and are tightly toleranced to restore the hydraulic integrity of the circuits.

G4A-EL
71846-01K with TV Cable
1 Boost Valve
1 Boost Sleeve
1 Boost Plug

GF4A-EL, F4A-EL (Mazda),
F4EAT (Ford)
74846-01K No TV Cable/with
Electronic Transmission

1 Boost Valve
1 Boost Sleeve
