Replacement 1-2 Accumulator Piston & Pins

Sonnax Part Summary

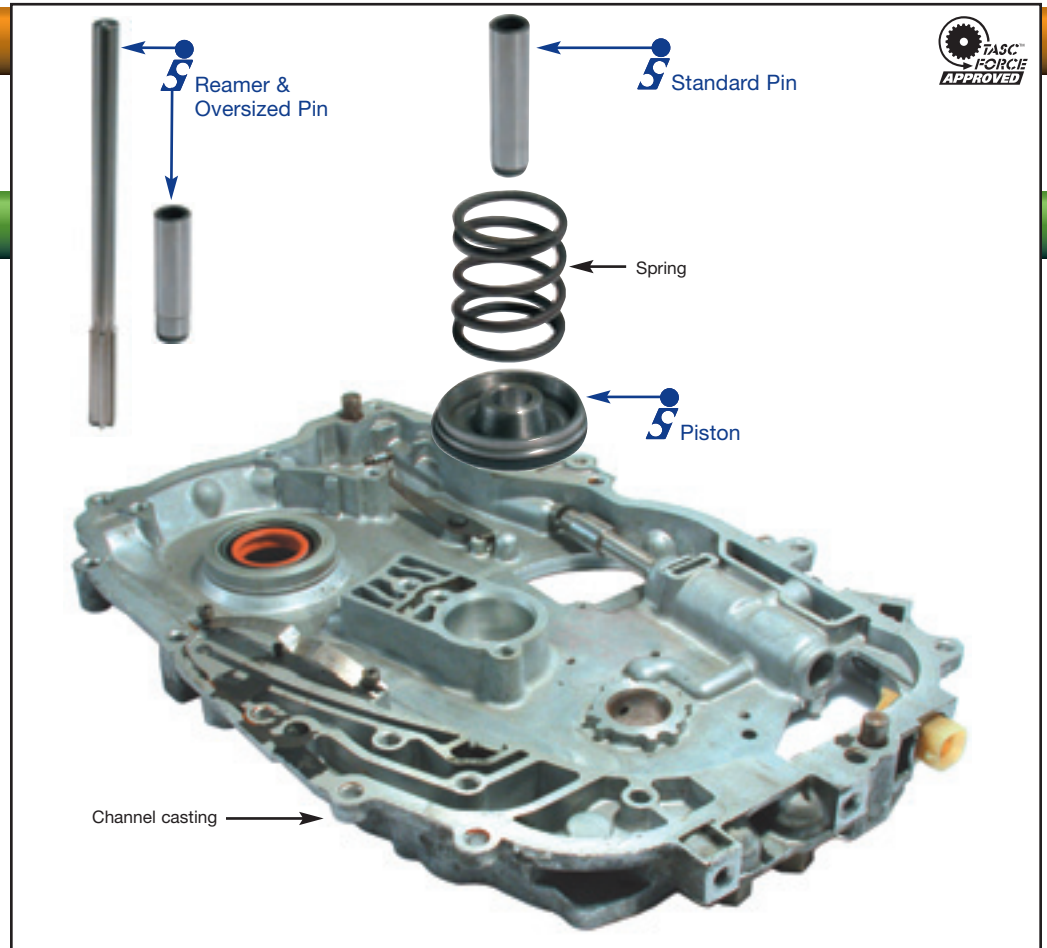
Burned forward clutches

- Delayed engagement • Poor shift quality • Wrong gear starts

The 1-2 accumulator piston wears at the pin bore due to contact with the steel pin.

This accumulator piston has a longer piston pin contact surface area to reduce wear on the piston and prevent cocking. Choose from the standardized replacement pin and piston, or optional reamer and oversized pins to salvage OE pistons.
