**Direct Drum
Shaft Retaining
Ring**

76811-01K
5 Retaining Rings

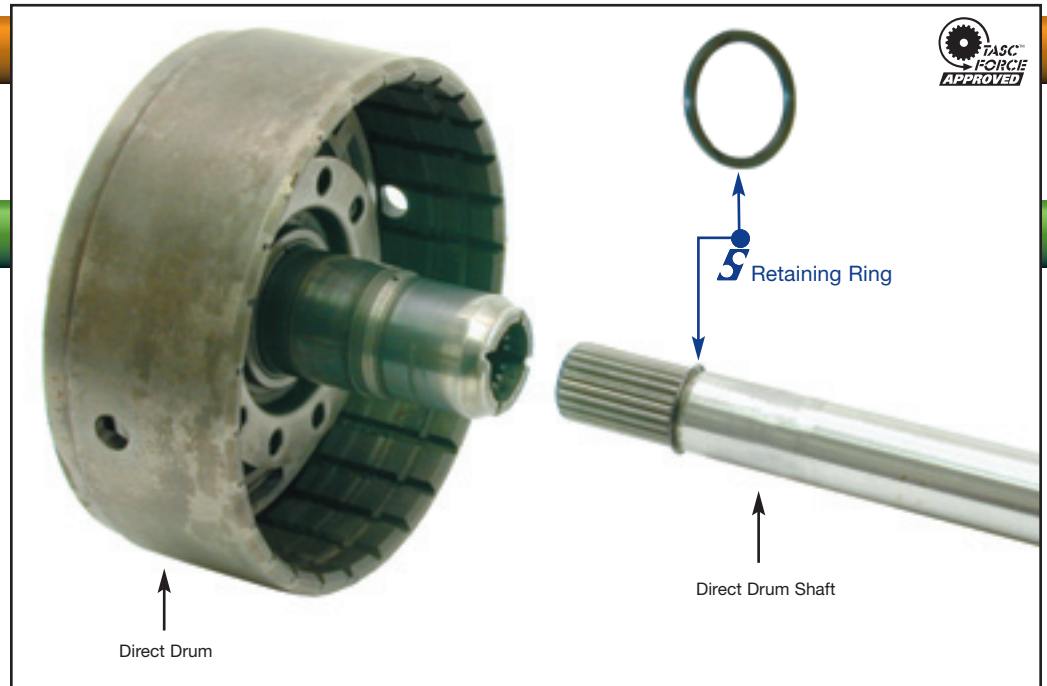
Restricted lube flow

Spline wear causes the direct drum shaft to contact the output shaft and shut off lube flow.

In vehicles with an AOD transmission, the direct drum splines can wear, causing the direct drum shaft to contact the output shaft and shut off lube flow. The late shaft design allows the Sonnax retaining ring 76811-01K to fit into the OEM groove. The early shaft design requires a groove to be machined to accept the retaining ring. The shaft has been depth hardened sufficiently from OEM to ensure strength after machining.

This retaining ring fit prevents the direct drum shaft from moving backward and contacting the output shaft and shutting off lube flow.
