4R70W, AODE

PART NUMBER 76833E

Overdrive Servo Pin

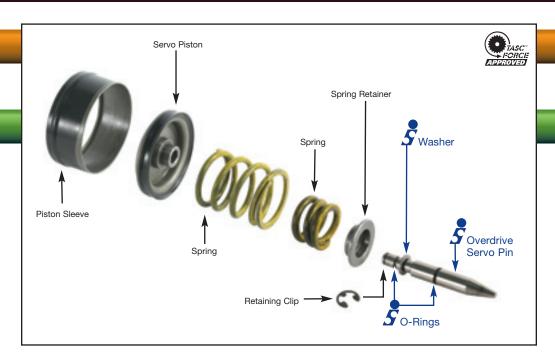
Overdrive band or forward clutch failure

The O.D. servo pin wears the case bore, causing oil circuit leaks.

In AODE transmissions, common problems are intermediate roller clutch, overdrive band or forward clutch failure, traced to the O.D. servo pin wearing the case bore. The oil circuit which releases or holds the servo off is present as forward clutch oil in 1, 2, 3 ranges. If this release oil leaks through the case, it can cause the O.D. band to drag and/or forward clutches to overheat. If band overheating becomes extensive, it may not hold in 4th gear, which can allow a neutral condition and excessive roller RPM on a re-engagement of 4-2 downshift. Replace the OEM servo pin with Sonnax **76833E**.

This overdrive servo pin positively seals against the piston I.D. and case bore.

- Pin has two o-rings to positively seal against the piston I.D. and the case bore, eliminating oil circuit leaks.
- Pin has an optional washer to pre-load the spring for a firmer 3-4 shift.
