## Low line pressure in forward, direct clutch failure

## 2-3 Accumulator Piston & Sleeve Kit

### 76890-21K

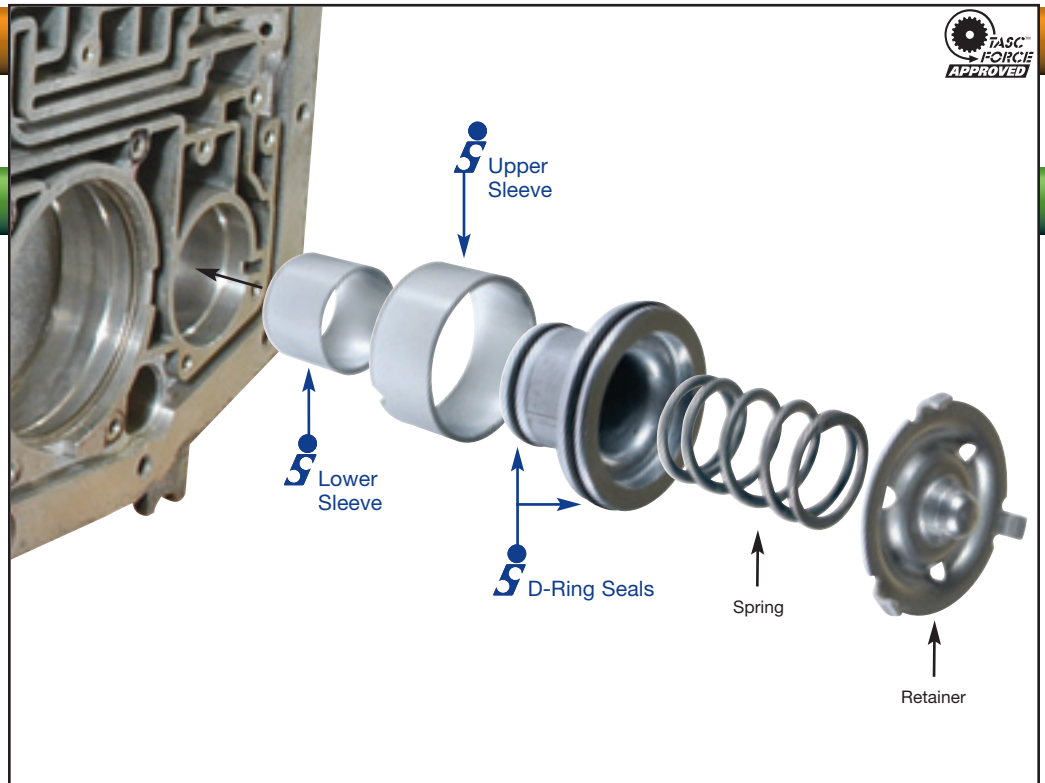
• No forward unless RPMs increased • OD band distress • Bonded piston seal delamination

Leakage of forward or direct clutch oil due to worn accumulator bores.

The Sonnax 2-3 accumulator kit includes two sleeves, a replacement piston and two D-rings so the case may be salvaged without machining, restoring proper piston clearances.

1 Accumulator Piston  
2 Sleeves  
2 D-Ring Seals
