Pressure Regulator Valve & Boost Sleeve Kit

Sonnax Part Summary

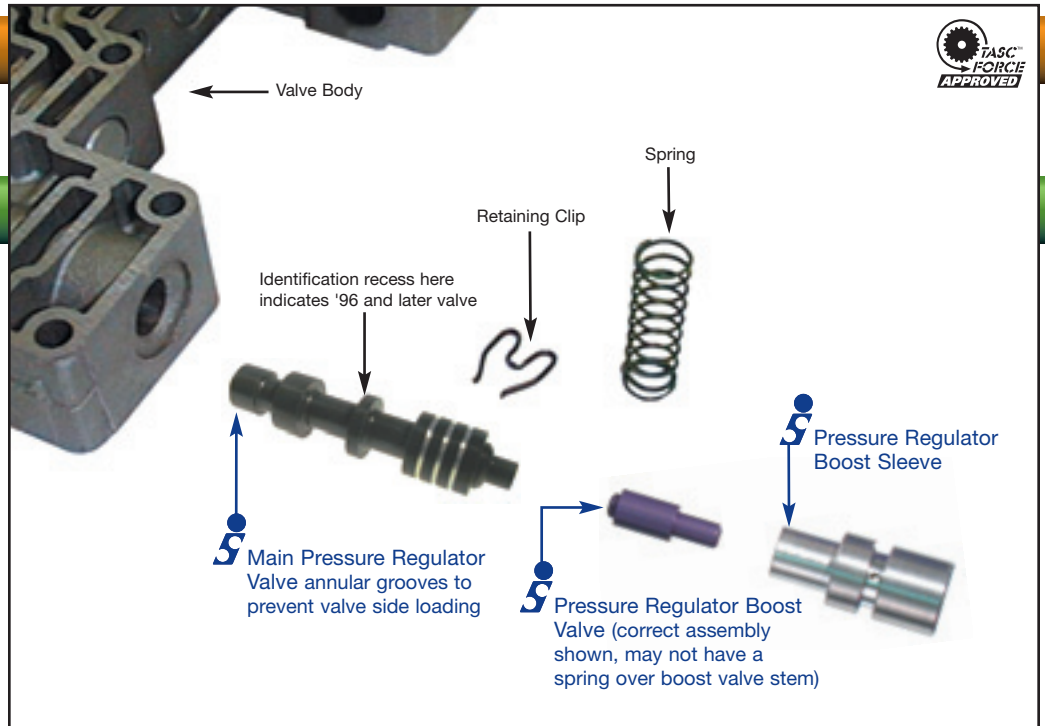
Premature clutch/band failure, poor reverse boost

• Poor soft shift quality • Insufficient line rise • Erratic buzz or uncontrollable pressure in reverse

A worn main regulator valve and worn reverse boost sleeve.

A common complaint in vehicles with AODE/4R70W transmissions is low line pressure or throttle sensitive buzz, especially when hot. This is often caused by a worn main regulator valve. The valve frequently wears on the boost spool diameter and allows EPC (electronic pressure control) oil to leak to exhaust. This leakage results in poor line rise. When the oil temperature increases, the oil becomes less viscous and more leakage occurs. The two Sonnax replacement assemblies **76948-01** and **76948-09** eliminate the above problems with a direct replacement main regulator valve. Another common complaint with these transmissions is poor reverse boost, often the result of a worn pressure regulator boost sleeve. The sleeve should be checked while replacing the main pressure regulator valve. Sonnax offers a replacement pressure regulator boost valve and sleeve kit **76948-02K**.

These direct replacement main regulator valves prevent EPC oil from leaking to exhaust, while the replacement pressure regulator boost valve and sleeve kit restores the level of line rise required for reverse.
