O-Ringed Valve End Plug Kits

Sonnax Part Summary

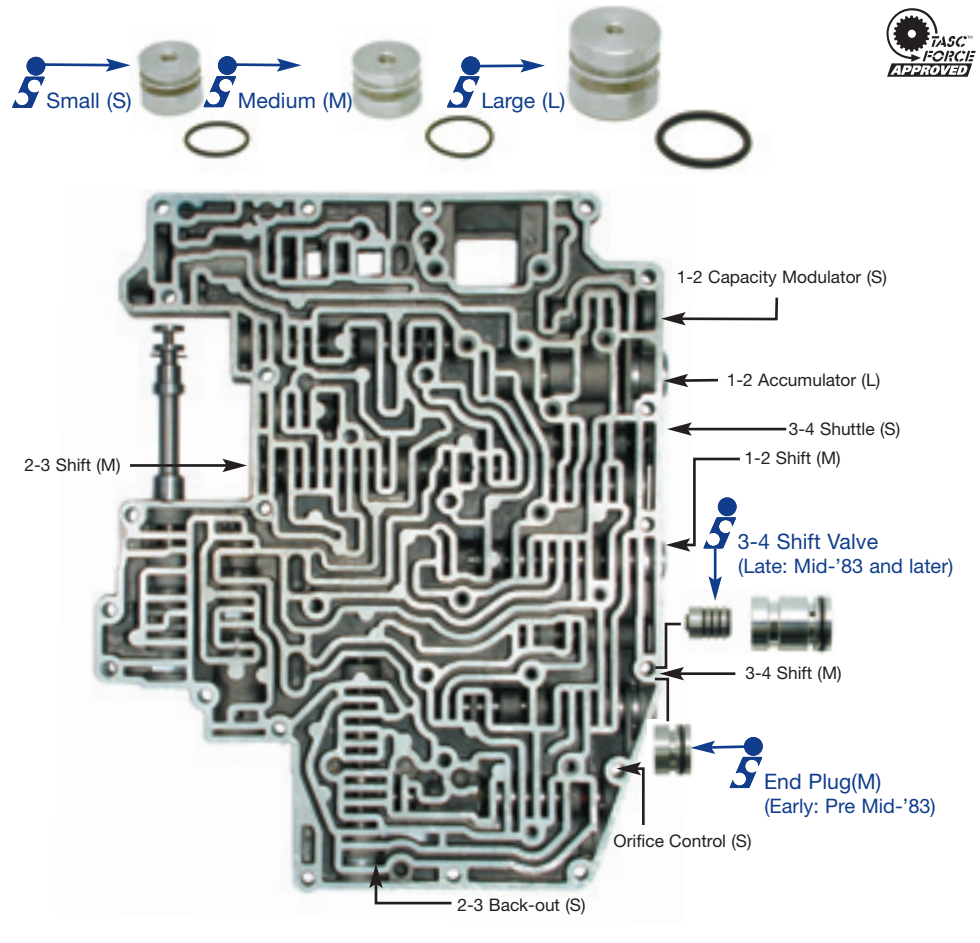
Erratic shift timing, oil leakage

Leaking valve end plugs in pre mid-'83 units, or worn 3-4 shift valve and sleeve in mid-'83 and later units.

Plugs are manufactured of high-quality aluminum to resist wear. The o-ring on the outside diameter prevents leakage between the plug and the valve body. The medium 3-4 plug is replaced by the 3-4 shift valve assembly after mid-'83.
