## Rear Planetary Rebuild Kit

### 77732-RK For 5-Pinion Planets

### Sonnax Part Summary

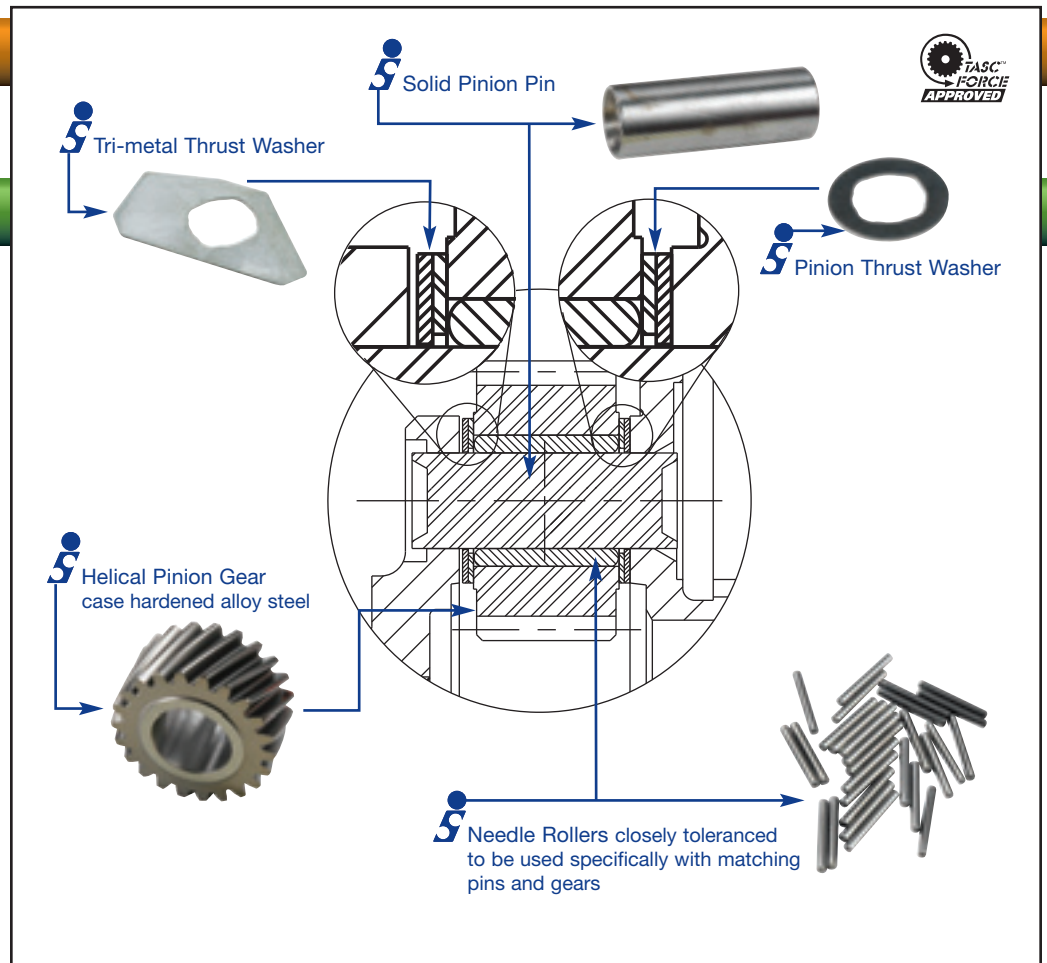
Planetary wear or failure

Insufficient lube oil and/or excessive clearances.

The rear planetary assembly in 4L65-E transmissions frequently wears out and must be replaced. New replacement assemblies can be costly, and the availability of quality aftermarket assembly component parts are limited. Planetary assembly wear is generally caused by insufficient lube oil and/or excessive clearances. Lack of lube causes excessive heat in the pinion gear area and causes the roller bearings to gall the gear bores and pinion pins. If there is excessive thrust washer wear or endplay, the roller bearings can run without fully contacting the gear bore, causing premature failure of the assembly. Sonnax now offers replacement parts necessary for rebuilding damaged rear planetary assemblies in the 77732-RK rebuild kit.

This kit offers replacement parts for rebuilding damaged rear planet assemblies and gives rebuilders the option of replacing only the worn components.
