**Aluminum 2-3 Shift Valve**

**77754-33**

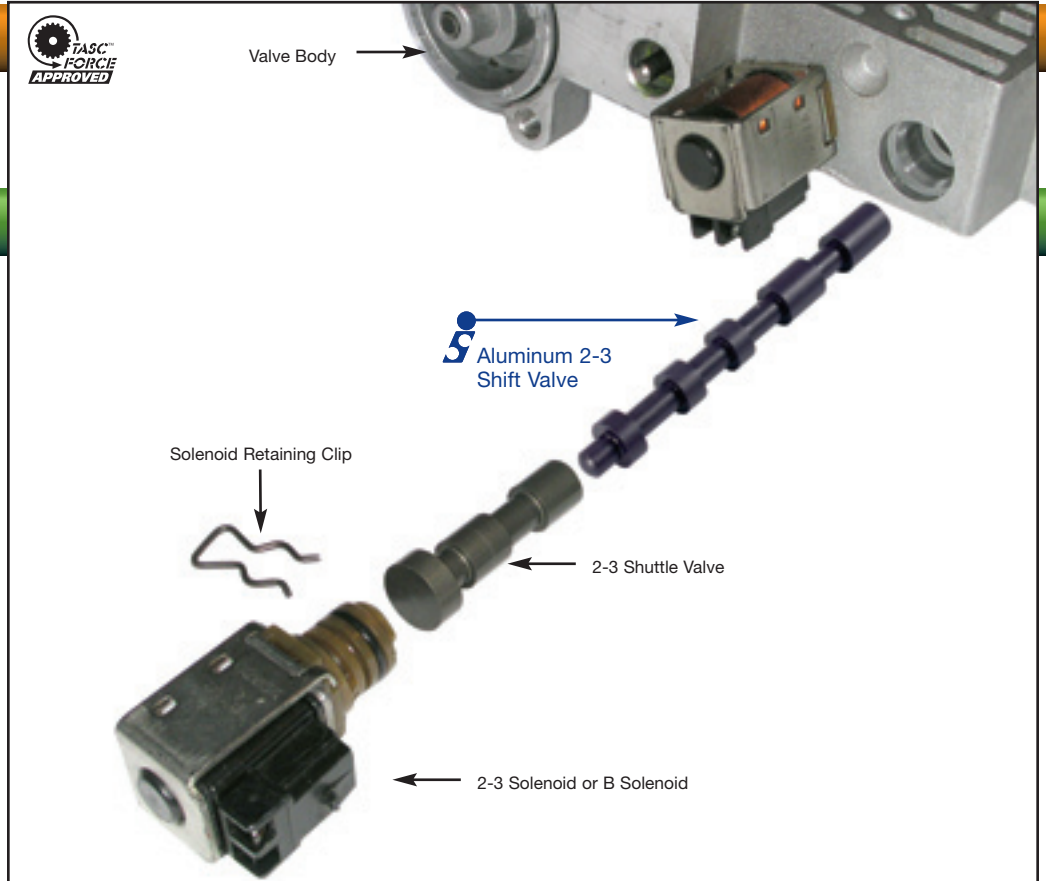
1, 2-3 Shift Valve

**2-3 shift valve sticks, Code 756, no 1st or 2nd**

The reduced expansion rate of the steel '93-'95 valve creates a cross leak. Valve bore wear causes the OE valve to hang.

This anodized aluminum valve can be used in all 4L60-E models to replace damaged valves and restore hydraulic clearance.
