**“Factory Style”
TV Boost Valve
& Sleeve**

Sonnax Part Summary

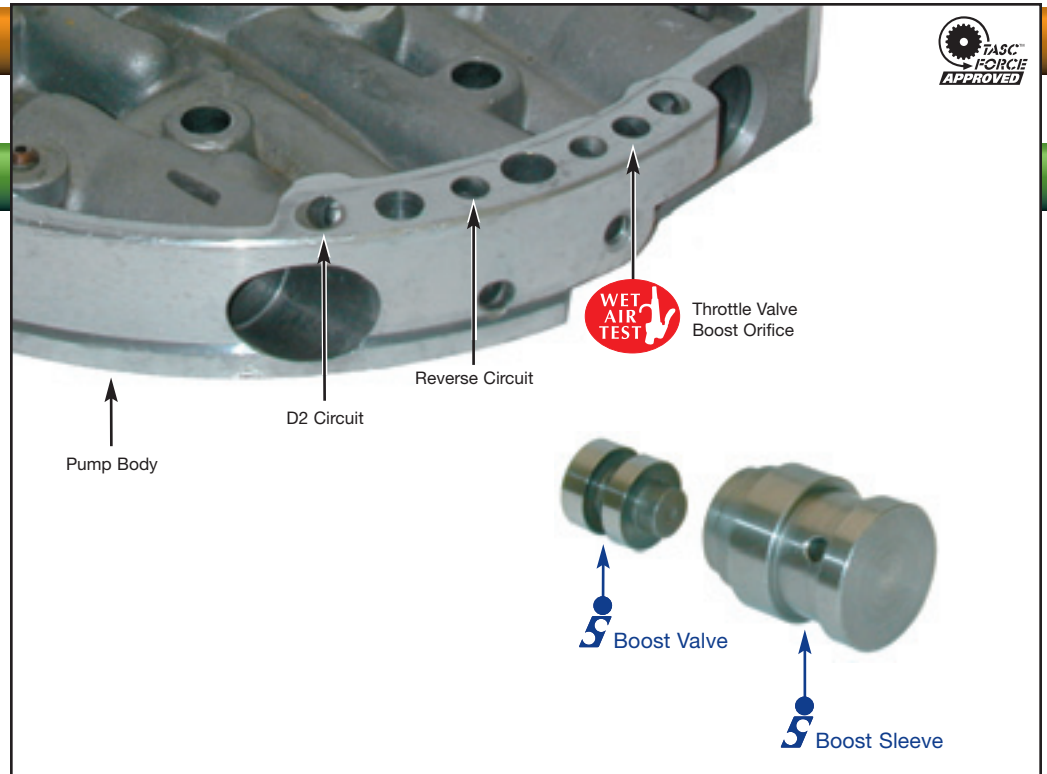
Burned 3-4 clutch

- Shortened band life • Soft slide shifts

MTV boost loss from insufficient line rise.

A common problem in 700-R4 transmissions is burned bands and/or 3-4 clutches. This failure can be reduced by eliminating throttle boost oil leakage. The Sonnax replacement assemblies 77917-02K, 77917-03K, and 77917-04K eliminate these problems.

Install the appropriate Sonnax TV boost valve kit.
