Torque Converter Clutch Solenoid Snout

Sonnax Part Summary

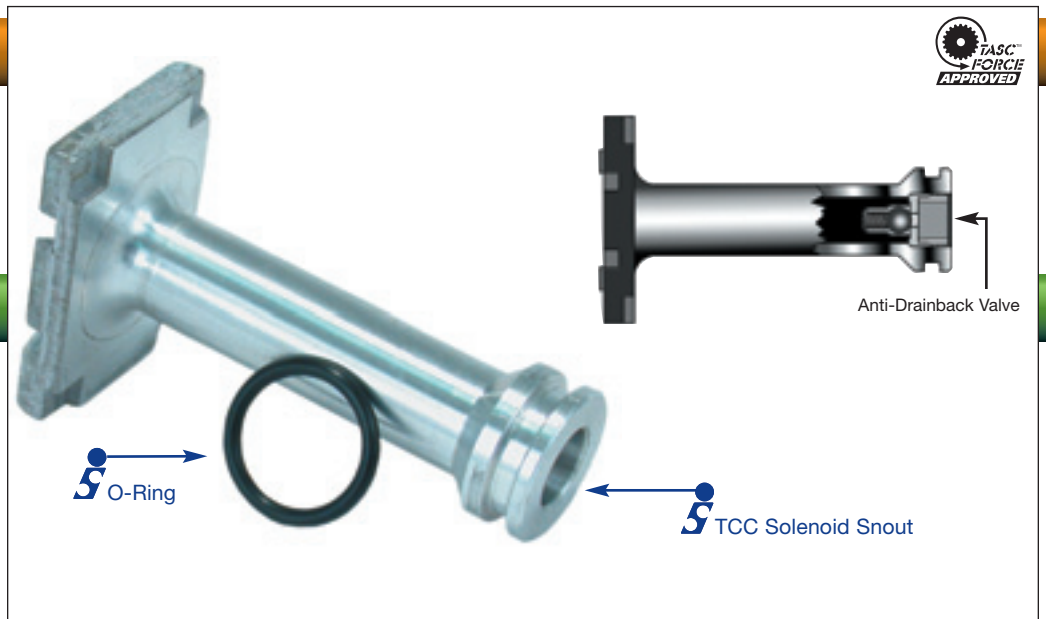
The OEM plastic solenoid snout cracks where it contacts the plunger valve, causing oil leaks, while the PWM TCC signal drainback valve becomes loose or melts and blocks the converter apply valve.

The plastic OEM torque converter clutch solenoid snouts are prone to breakage, causing them to leak oil that should be directed to the converter clutch apply valve. Until now, your only option was to replace the entire OEM harness or purchase an aftermarket solenoid and splice it into the existing harness. The new Sonnax solenoid snout **77942-01K** allows the OEM solenoid to be rebuilt to better-than-new condition, while our TCC solenoid snout **77942-02K** eliminates the need for the damage-prone plastic OEM drainback valve.

Replace the broken solenoid snout with an aluminum snout either with or without a built-in anti-drainback valve.
