Throttle Valve Plunger & Sleeve Kits

Sonnax Part Summary

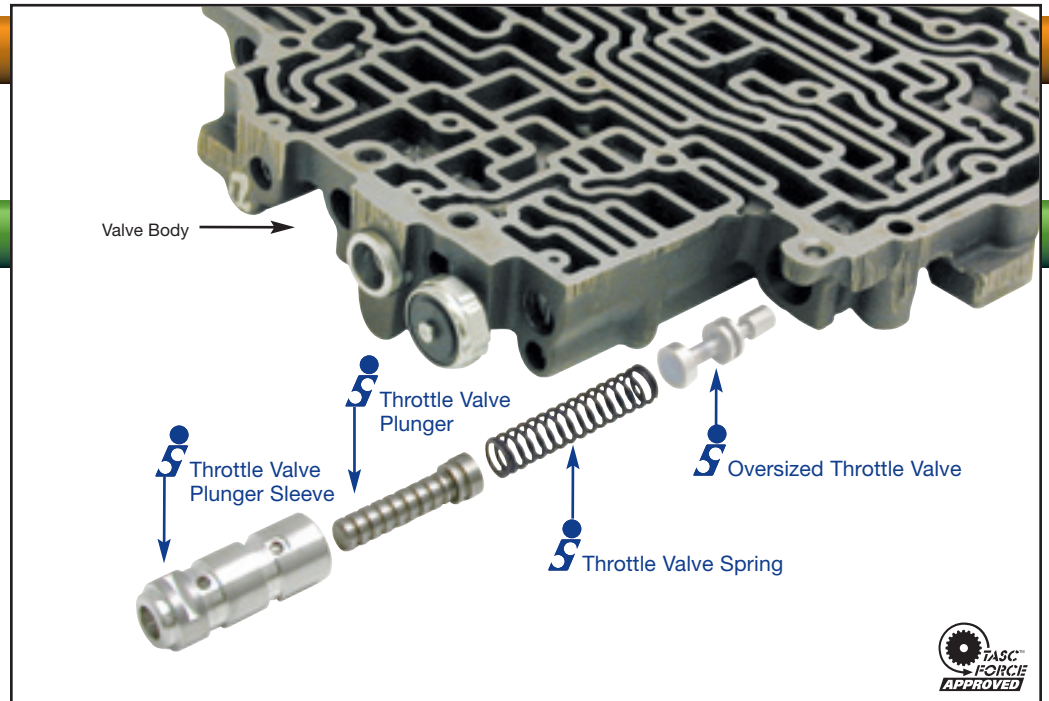
The steel TV plunger wears the TV plunger sleeve, allowing TV feed oil to leak past the plunger and exhaust.

Poor line rise or no detent downshifts can be common complaints in vehicles with a THM 700-R4 transmission. The steel throttle valve plunger continuously reciprocates within the aluminum throttle valve plunger sleeve, wearing the sleeve. This wear allows throttle valve feed oil to leak past the plunger and exhaust, resulting in poor line rise and problematic downshifts. In addition, the OEM spring is weak and can result in low line rise, insufficient throttle pressure and, ultimately, 3-4 clutch failure.

These valve and sleeve kits restore the hydraulic integrity of the circuit.
