Oversized Throttle Valve

77968

Sonnax Part Summary

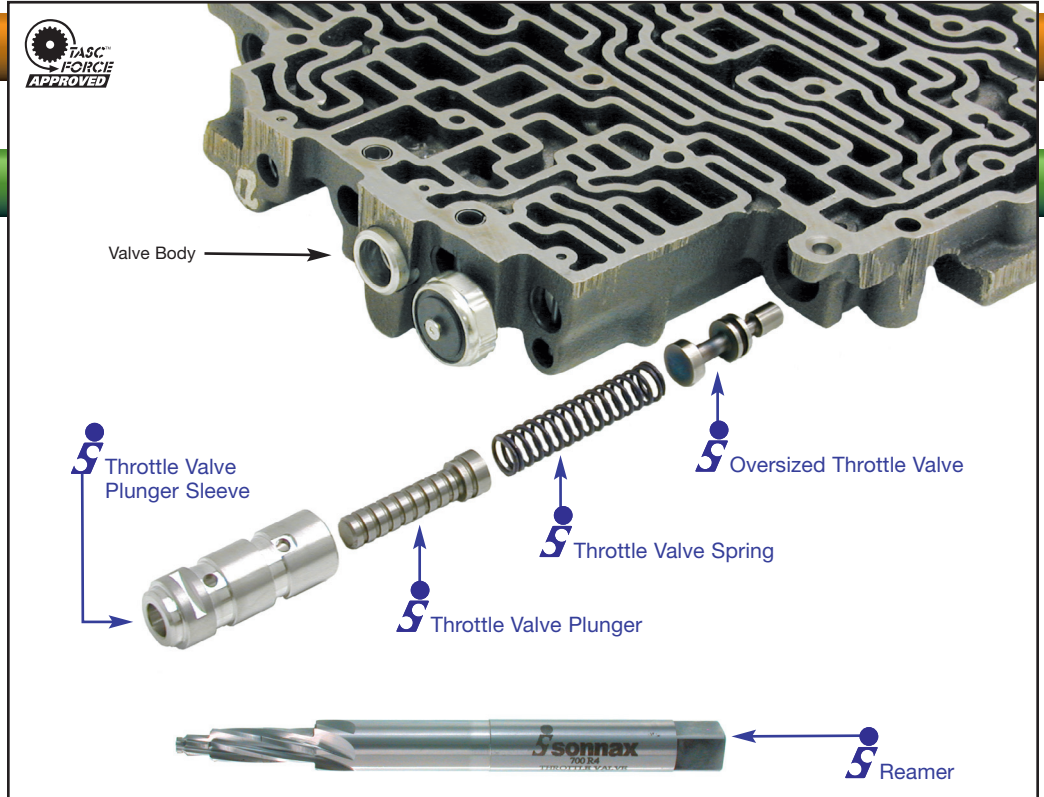
Poor line rise

- 3-4 clutch and band failure

A low throttle boost oil condition.

A low throttle boost condition is a common complaint in vehicles with 700-R4 transmissions. This loss of throttle boost oil creates poor line rise and accelerates 3-4 clutch and band failure. In late-model transmissions, the hardened steel throttle valve continuously oscillates in the cast iron valve body bore and eventually wears the three bore diameters. This wear allows throttle valve feed oil to leak past the valve spool and exhaust, resulting in a low throttle boost condition. This excessive leakage can be eliminated by installing the oversized Sonnax replacement throttle valve 77968.

Stop the excessive leakage by installing this oversized replacement throttle valve that has slightly larger spool diameters.

- The three spool diameters on this valve are slightly larger than the late model OEM valve, allowing the valve body bore to be modified to restore the hydraulic integrity of the assembly.
- The valve body bore can be made large enough to accept this replacement valve by reaming it with the specially designed reamer 77968-RM, which has three tightly-toleranced cutting diameters that will slightly enlarge the valve body bore in the area of the throttle valve.
- Use of reamer eliminates miscalibration or similar wear when exchanging with another used valve body.
