PART NUMBER 84596-01K

Channel Plate Sleeve

Sonnax Part Summary

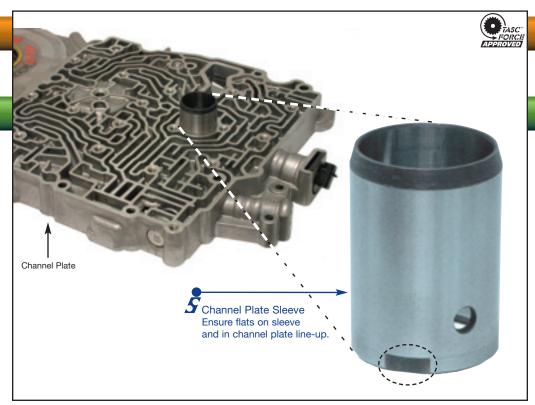
Worn channel plate sleeve

Drive sprocket, bearing failure cause channel plate (case cover) sleeve wear.

Replace the worn channel plate sleeve with 4T65-E thru-hardened replacement sleeve.

OEM does not service the 4T65-E channel plate sleeve as an individual part. In the past it was necessary to purchase a channel plate (case cover) assembly. Sonnax now offers a replacement thruhardened sleeve, **84596-01K**.
