AFL Valve & Sleeve Kit

84596-02K

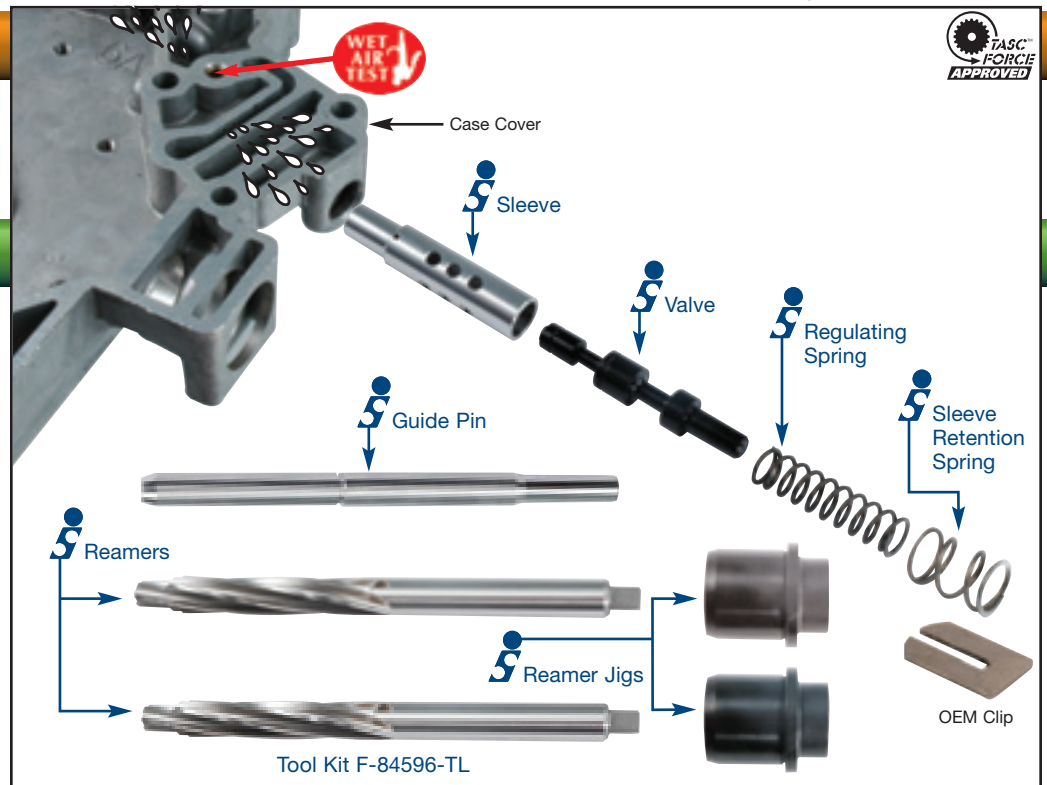
Code 1811, maximum adapt or long shift, TCC slippage

• TCC piston failure • Excessive line pressure • Poor EPC control • 2nd gear starts

Actuator feed limit bore wear results in unregulated pressure at the EPC solenoid, 1-2, 3-4 shift solenoid and the 1-2, 3-4 shift signal circuit.

The OEM actuator feed limit (AFL) valve routes regulated line pressure to the pressure control solenoid and the 1-2, 3-4 shift signal circuit. Wear at the AFL valve bore can cause low torque signal and/or low 1-2, 3-4 shift solenoid and shift signal circuit pressure, resulting in Code 1811, maximum adapt or long shift, TCC slippage and wrong gear starts. Bore wear can also cause poor EPC control, leading to high line pressure and TCC piston damage. The Sonnax AFL valve and sleeve kit **84596-02K** restores hydraulic integrity to the AFL circuit.

This wear-resistant sleeve and valve assembly allows the salvage of the case cover by re-establishing hydraulic integrity of the AFL circuit.

Due to the nature of the channel plate design, the Sonnax Valve Body Reaming Fixture **VB-FIX** is required to use this tool kit.

- Highly wear-resistant aluminum sleeve provides more support and durability to prevent wear.
- Wear resistant hard-anodized valve maintains proper clearance with thermal expansion.
- Annular grooves center the valve to prevent wear.
- Regulating pressure is reduced by about 10 psi to prevent high line pressure, which can lead to TCC piston damage.
