## 3-4 Accumulator Piston

84880M-01

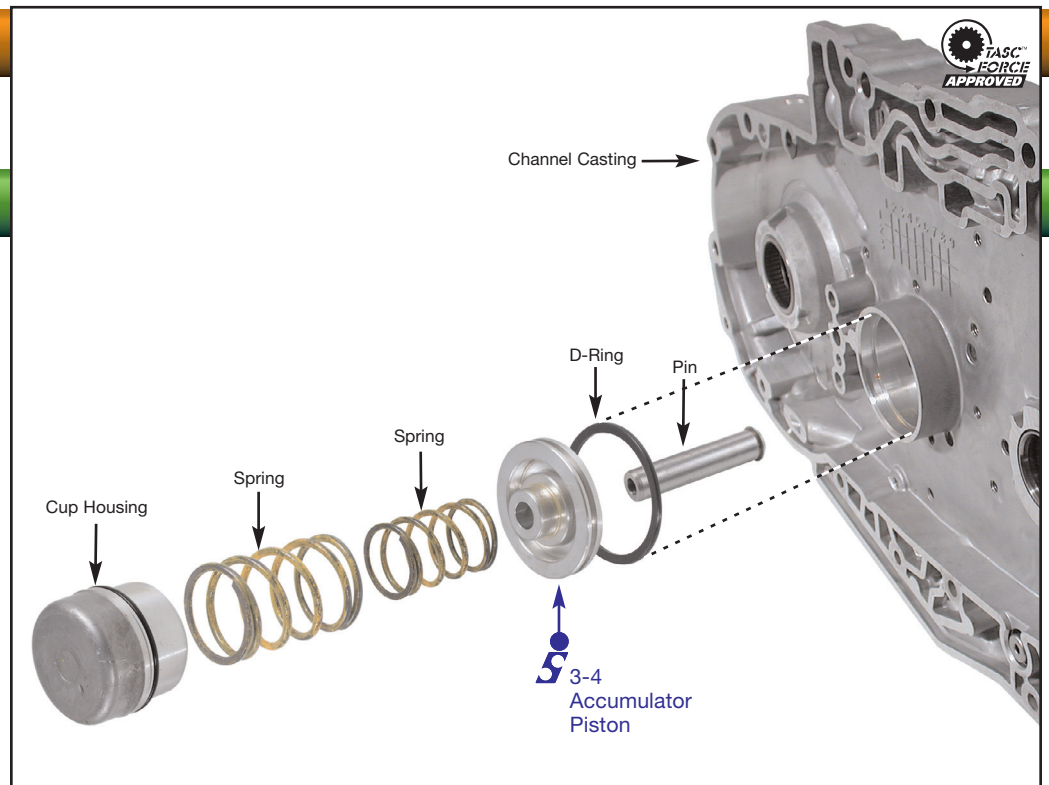
Wear at the 3-4 accumulator piston pin or bore.

It is common to have poor 3-4 shifts, no 4th gear or a burned 4th clutch in 4T65-E units. This can be caused by excessive wear at the 3-4 accumulator piston pin bore, which allows 4th clutch oil to exhaust and can result in harsh 4th, no 4th gear or a burned 4th clutch. Pin bore wear also reduces 3rd clutch pressure during 3-4 shift. The 4th shift quality depends on the condition of the piston and accumulator valves. If the 4th accumulator piston seizes, the 4th shift will be very hard. The Sonnax accumulator piston **84880M-01** restores accumulator pressure and eliminates cross leaks.

The Sonnax piston is made from high-grade billet aluminum to prevent wear and restores clearances at the pin.
