**Axle/Side Leak Repair Plate**

**84995-01**

**Sonnax Part Summary**

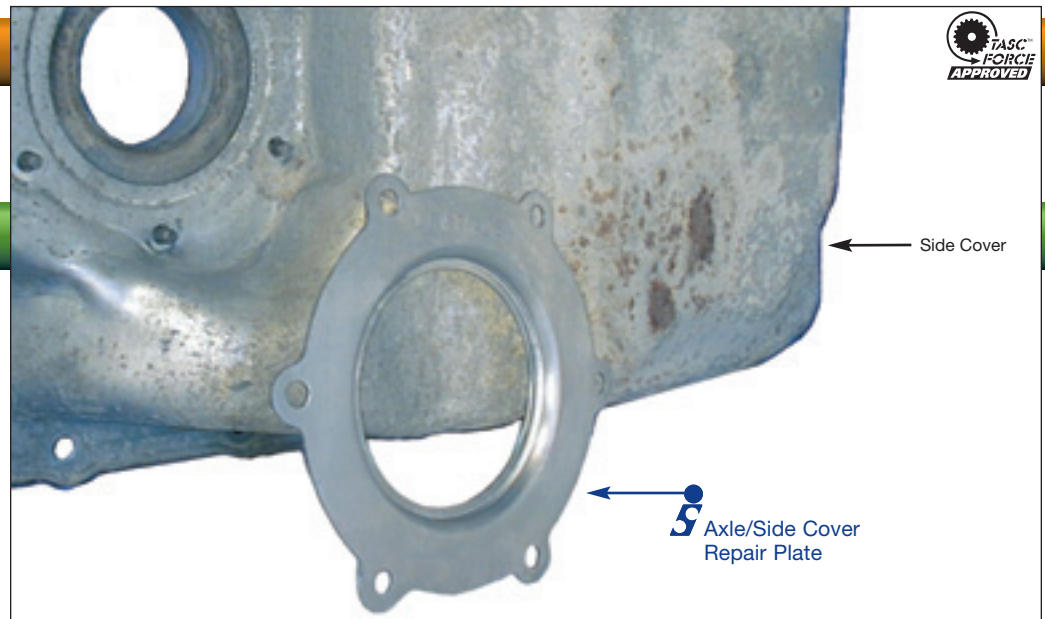
Leakage of oil at side cover to channel plate inner gasket

4th clutch heat, side cover corrosion, crushing or splitting of the gasket when the side cover pan nuts are torqued.

Fix the leak without removing the side cover or replacing the failed gasket with this leak repair plate.

- Plate is designed to be attached to the outside of the side cover utilizing the existing channel plate studs.
- The dished shape of the plate presses against both the side cover and the channel plate, sealing off the potential leakage area.
