## Poor line pressure control

## Oversized Pressure Regulator Valve & Tool Kit

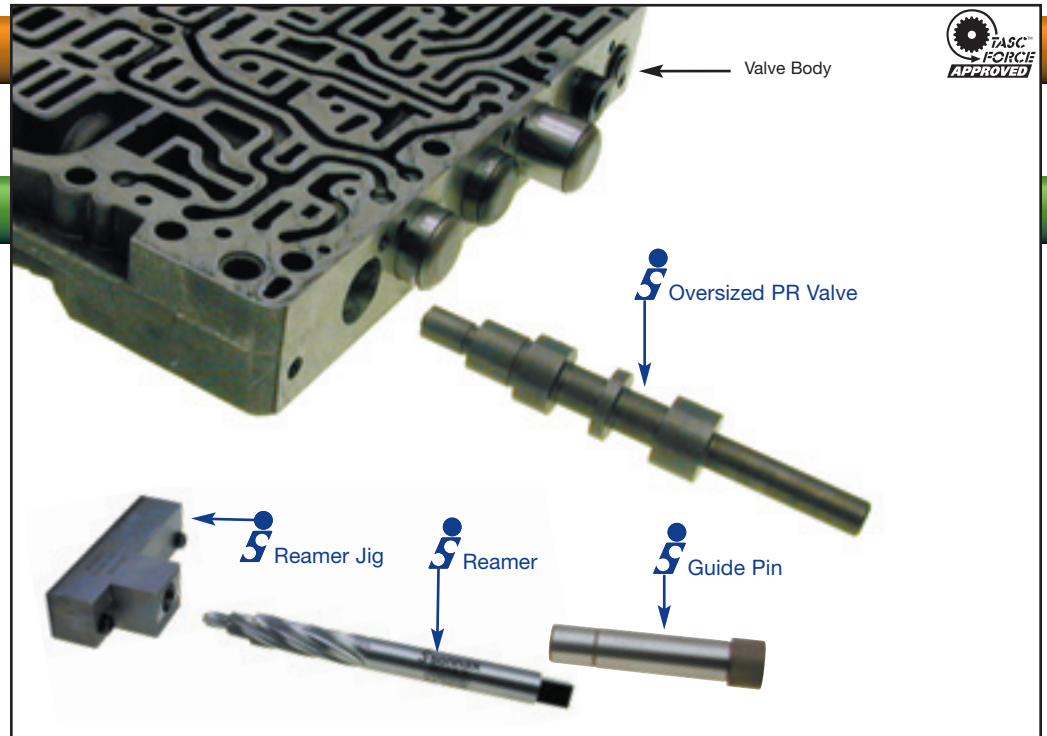
Oscillation of the aluminum valve wears out the pressure regulator bore.

Many vehicles with either a ZF4HP14 or ZF4HP18 transmission experience poor line pressure control due to a worn pressure regulator bore. This bore wear can be verified by testing line pressure and/or performing a Wet Air Test on the valve body. The past fix was to replace the valve body, which is expensive and hard to find. These problems are often caused by wear from the oscillation of the aluminum valve in the valve body bore. Line/balance, modulated TV, and converter/cooler pressures then leak past the valve and exhaust to the sump or cross leak into other circuits. Excessive leakage can be eliminated by installing the oversized Sonnax replacement pressure regulator valve **85991-01**.

Eliminate excessive leakage by reaming the valve body bore and installing the oversized replacement pressure regulator valve.
